Direct Inspect

Home Inspection Report

123

Inspected on Thu, Dec 11 2014 at 9:00 AM

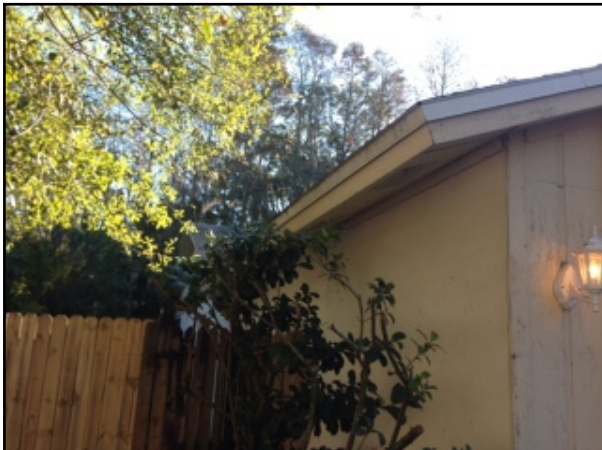
Figure 1-1

1. Recommend trimming all vegetation away from the roof line.
2. Additional area where the vegetation needs to be maintained away from the roof structure.
3. Pavers on the side of the home are uneven and need to be re-leveled.
4. Additional vegetation which should be maintained away from the structure.

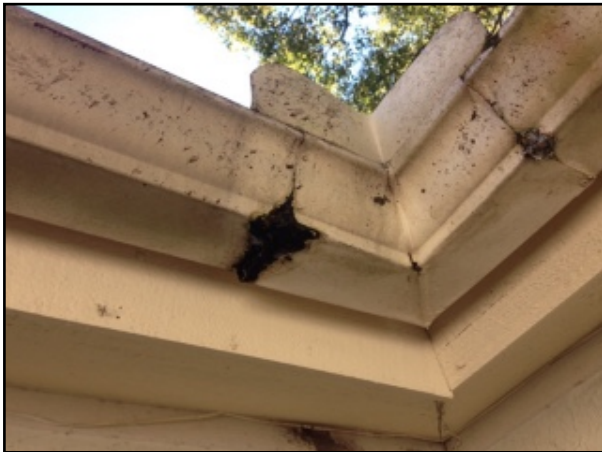
Figure 2-1

1. Recommend sealing the seem at the gutter to ensure a tight seal.
2. Wood siding is warping and splitting recommend repair.
3. Bottom of garage door is peeling recommend repair and continued monitoring.
4. Wood trim has moisture damage and needs to be repaired.
5. Coachlight is loose and needs to be secured properly.
6. Recommend caulking all corners of fascia boards to ensure a tight seal.
7. Siding in front of the house is touching the soil recommend regrading to ensure that the soil is not touching the siding.
8. Recommend extending gutter downspout away from the structure.
9. Bottom portion of the home is stained and some of the paint is peeling recommend repair.
10. Side garage door paint is chipping and peeling recommend repair.

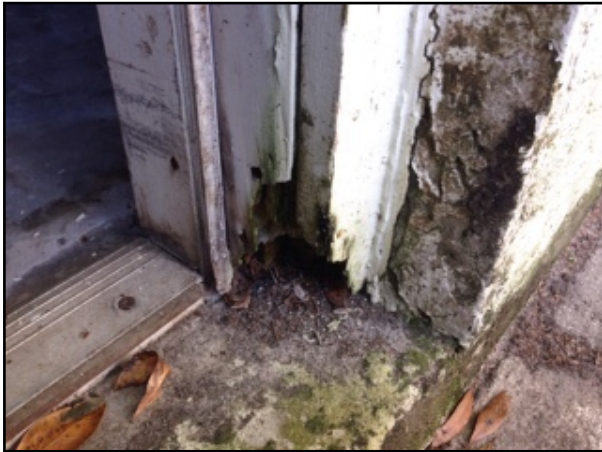
Figure 3-1

1. Trim around side door garage has moisture damage and needs to be replaced.
2. Recommend extending gutter downspout away from the structure.
3. Screen is torn and has mildew and mold recommend replacing screen.
4. Additional photo showing mildew on the screen.
5. Recommend removing vine from back screen enclosure.
6. Screen door is damaged and needs to be repaired.
7. Siding has moisture damage and is warping recommend sealing properly and repairing as needed.
8. Step crack noted on the structure recommend caulking and continue to monitor.
9. Additional step crack noted caulk and continue to monitor.
10. Larger step crack noted recommend caulking and continue to monitor.

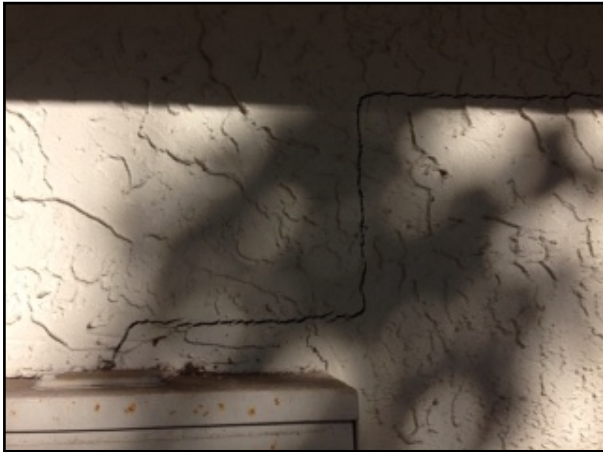
Figure 4-1

1. Additional step crack noted caulk and continue to monitor.
2. Recommend removing all debris off of the screen enclosure.
3. Several windows are missing screens.
4. Additional screen which is damaged and needs to be repaired.
5. Ceiling under the covered patio is chipping and peeling recommend repainting.
6. Ceiling fans are damaged and need to be replaced with proper outdoor fans.
7. Exterior trim at patio door is damaged and should be replaced.

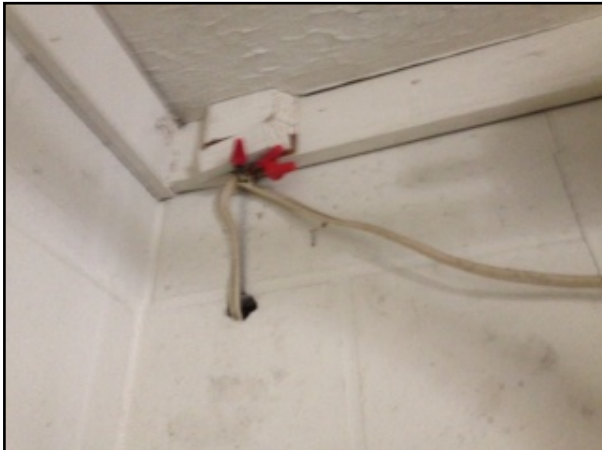
Figure 5-1

1. Coachlight wiring junction is exposed, wire needs to be in a proper electrical box. Electrical wire needs to be in a conduit. Recommend further evaluation by a licensed electrician.
2. Recommend replacing older GFCI receptacle with a new GFCI receptacle.

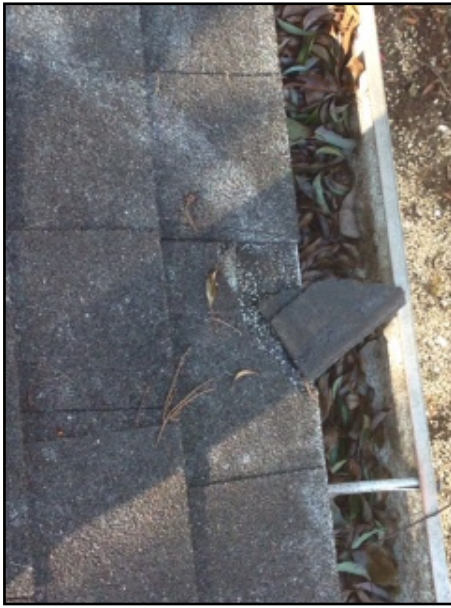
Figure 7-1

1. Shingle is damaged and needs to be repaired.
2. Recommend cleaning all valleys of leaves and debris to allow for proper water discharge.
3. Back of the chimney has severe moisture damage recommend replacing all trim around the chimney.
4. Additional photo of damage around chimney.
5. Damage noted around trim at chimney recommend replacing.
6. Bottom of the chimney trim has a moisture damage recommend replacing all trim and adding additional flashing to deviate water away from the chimney.
7. Shingles in this area are slightly worn due to debris from tree branches and leaves. Continue to monitor.
8. Recommend adding screens to all roof vent stacks.
9. Additional area on the roof which is worn continue to monitor.
10. Small piece of shingle is loose and needs to be secured or repaired.

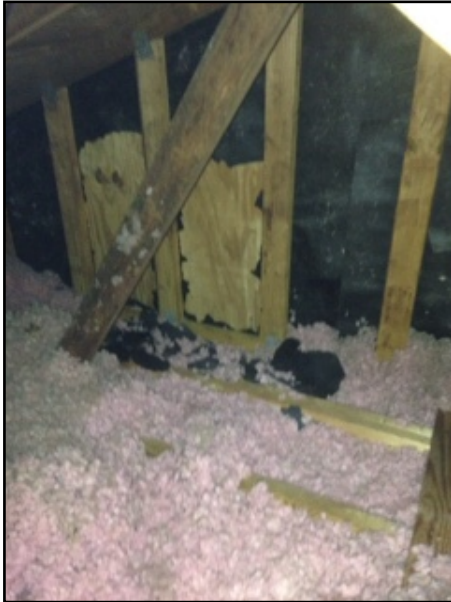
Figure 9-1

1. Some of the vapor barrier has come loose recommend adding new barrier.
2. Moisture noted inside the chimney walls due to the exposed area on the roof. Recommend repairing as soon as possible to avoid further damage.

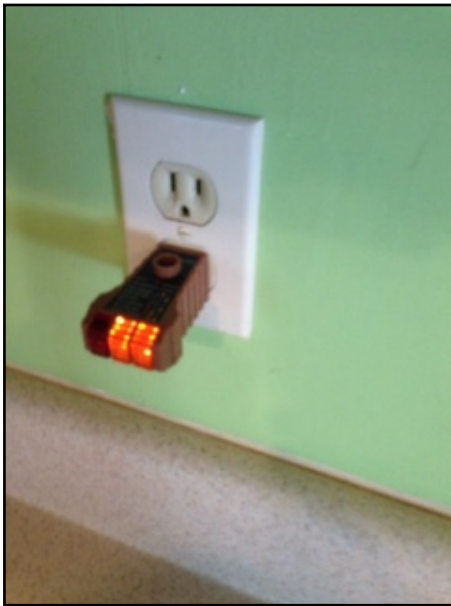
Figure 11-1

1. Recommend replacing receptacle in kitchen with GFCI receptacle.
2. Additional receptacle in the kitchen which should be switched out to a GFCI receptacle.
3. Receptacle was loose and needs to be looked at by a licensed electrician. The power was intermittent.
4. Receptacle was inoperable recommend further evaluation.
5. Smoke detectors were both functional however when the smoke detectors turn yellow this is a sign that they should be replaced.

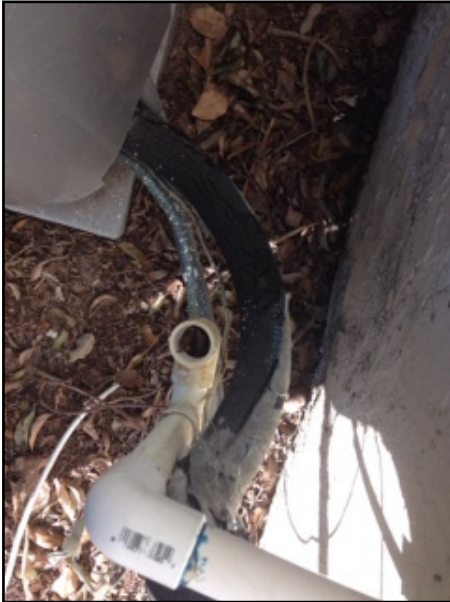
Figure 14-1

1. Insulation around suction line is starting to deteriorate recommend replacing insulation.
2. Coil is dirty and needs to be cleaned recommend having A/C system serviced.

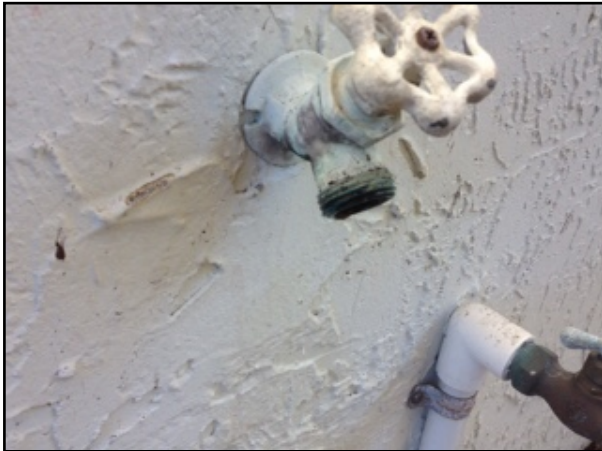
Figure 15-1

1. Exterior hose bib is leaking recommend repair.

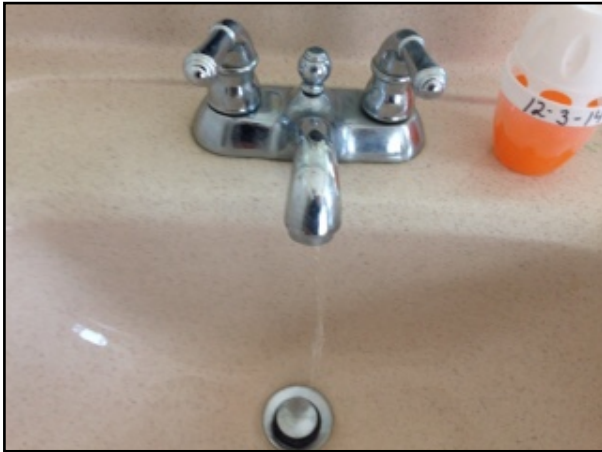
Figure 19-1

1. Water pressure was low recommend cleaning filter to see if the pressure is better.
2. Low water pressure on shower recommend cleaning or replacing shower head.
3. Window does not lock properly. Several windows are missing their locking mechanism and have small side locks.
4. Mirror is damaged at the bottom, cosmetic.

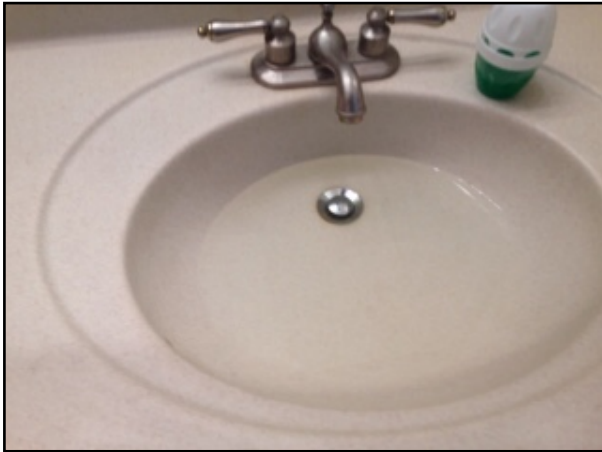
Figure 21-1

1. Sink was slow to drain recommend unclogging the drain.
2. Repair noted behind toilet checked with moisture meter no active moisture noted.
3. Recommend caulking around tiles to ensure a tight seal.
4. Tub has a small rust spot try to seal and continue monitoring.

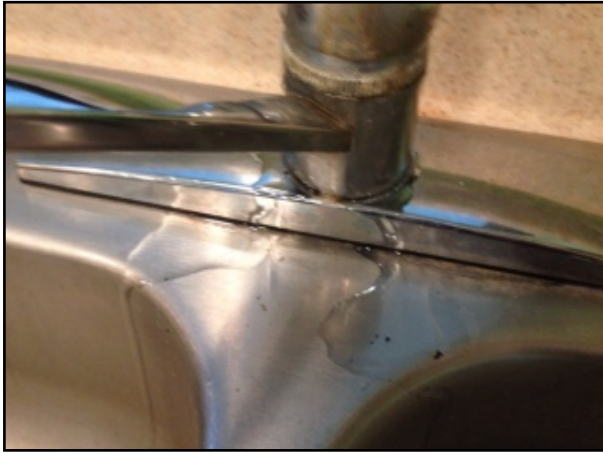
Figure 22-1

1. Leak noted at faucet fixture when turned on replace fixture.
2. Water noted at base cabinet from leak.
3. Leak appears to be coming from the faucet fixture repair or replace as needed.

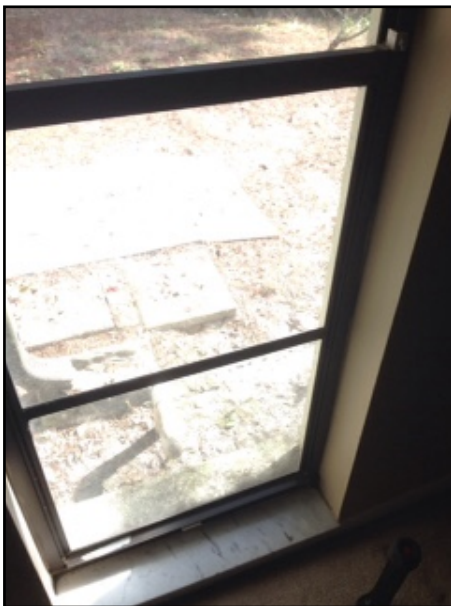
Figure 26-1

1. Several windows where difficult to operate recommend repair or replacement.
2. Ceiling fan is missing light fixture housing.
3. Several windows are missing screens and where difficult to operate.
4. Drywall repair needed at front window.
5. Door is missing at the front office.
6. French door latch is sticking recommend adjusting door.
7. Several holes noted on the walls recommend patching and painting.
8. Firebrick has a small crack continue to monitor and repair as needed.
9. Recommend having chimney cleaned and serviced on a yearly basis.

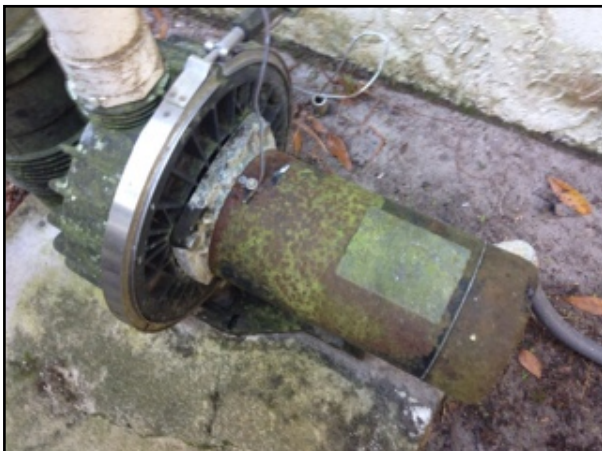
Figure 28-1

1. Pool motor needs to be replaced.
2. Rust noted at the bottom of the exterior shut off panel. Paint and continue to monitor.
3. Skimmer housing cover is missing.
