Direct Inspect

Home Inspection Report

123

Inspected on Thu, Dec 11 2014 at 9:00 AM

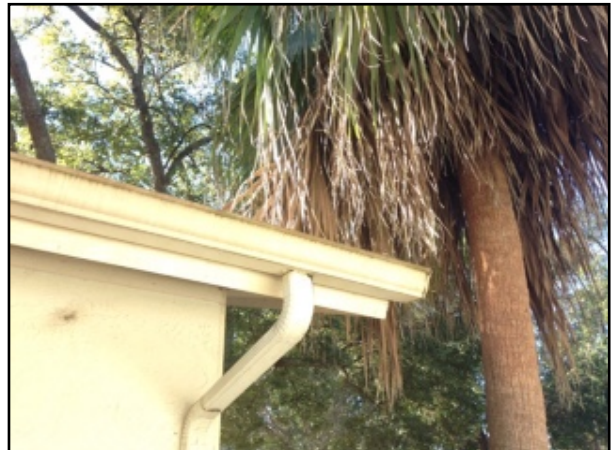
Figure 1-2

1. Recommend trimming all vegetation away from the roof line.
2. Additional area where the vegetation needs to be maintained away from the roof structure.
3. Pavers on the side of the home are uneven and need to be re-leveled.
4. Additional vegetation which should be maintained away from the structure.

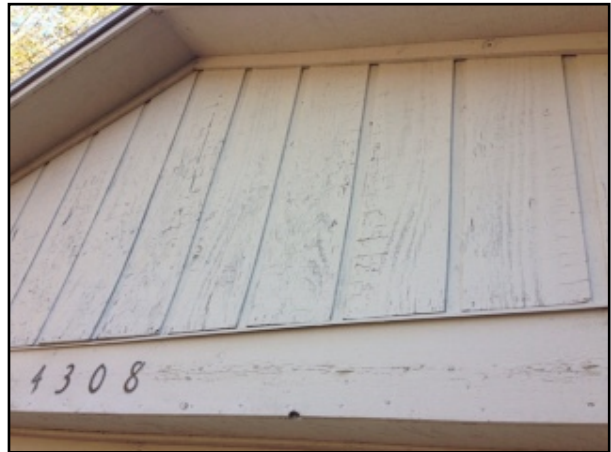
Figure 2-2

1. Recommend sealing the seem at the gutter to ensure a tight seal.
2. Wood siding is warping and splitting recommend repair.
3. Bottom of garage door is peeling recommend repair and continued monitoring.
4. Wood trim has moisture damage and needs to be repaired.
5. Coachlight is loose and needs to be secured properly.
6. Recommend caulking all corners of fascia boards to ensure a tight seal.
7. Siding in front of the house is touching the soil recommend regrading to ensure that the soil is not touching the siding.
8. Recommend extending gutter downspout away from the structure.
9. Bottom portion of the home is stained and some of the paint is peeling recommend repair.
10. Side garage door paint is chipping and peeling recommend repair.

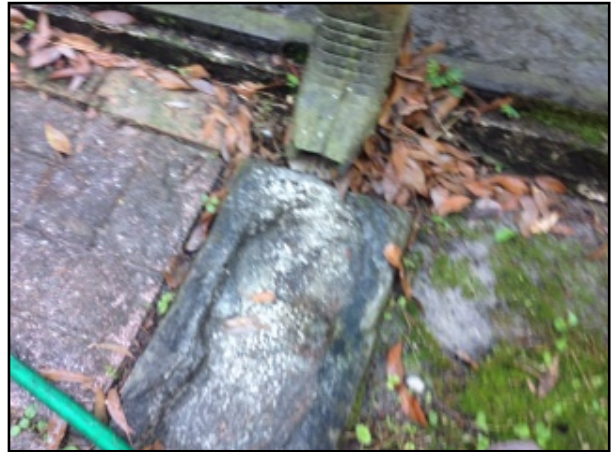
Figure 3-2

1. Trim around side door garage has moisture damage and needs to be replaced.
2. Recommend extending gutter downspout away from the structure.
3. Screen is torn and has mildew and mold recommend replacing screen.
4. Additional photo showing mildew on the screen.
5. Recommend removing vine from back screen enclosure.
6. Screen door is damaged and needs to be repaired.
7. Siding has moisture damage and is warping recommend sealing properly and repairing as needed.
8. Step crack noted on the structure recommend caulking and continue to monitor.
9. Additional step crack noted caulk and continue to monitor.
10. Larger step crack noted recommend caulking and continue to monitor.

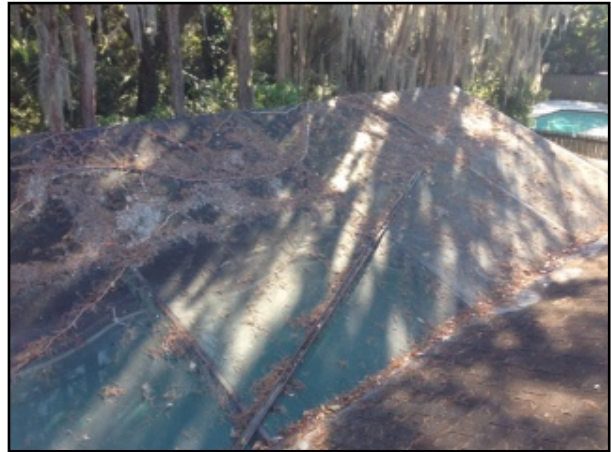
Figure 4-2

1. Additional step crack noted caulk and continue to monitor.
2. Recommend removing all debris off of the screen enclosure.
3. Several windows are missing screens.
4. Additional screen which is damaged and needs to be repaired.
5. Ceiling under the covered patio is chipping and peeling recommend repainting.
6. Ceiling fans are damaged and need to be replaced with proper outdoor fans.
7. Exterior trim at patio door is damaged and should be replaced.

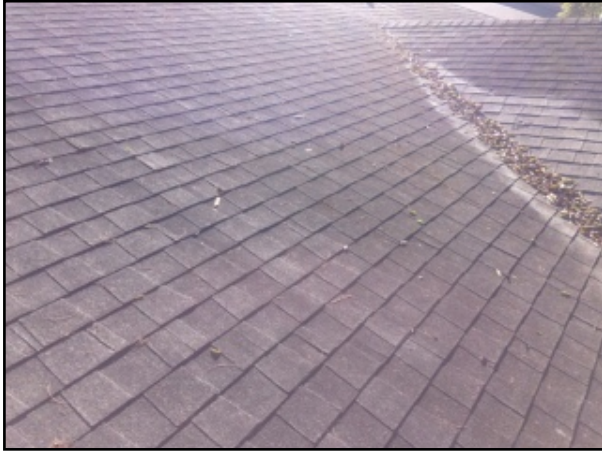
Figure 6-1

1. Dimensional photo noted.
2. Additional photo of dimensional shingle noted. Roof was permitted in 2006.

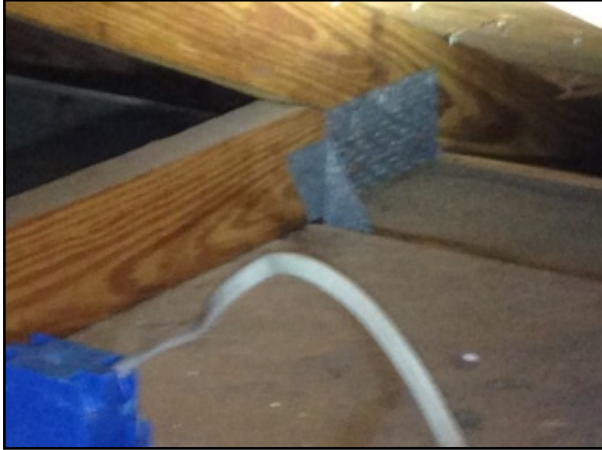
Figure 8-1

1. Hurricane clip noted.
2. Additional photos of hurricane clips noted in the attic.
3. Gable end bracing noted in the attic.
4. 8d nails noted on the roof decking.

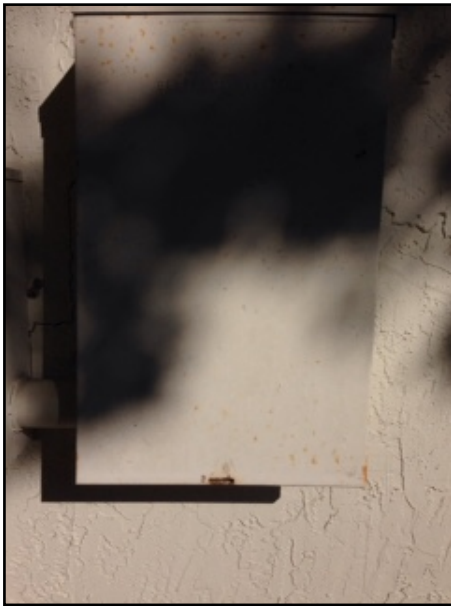
Figure 10-1

1. GE 200 amp panel located outside.
2. GE breaker panel cover noted.
3. Inside the GE 200 amp panel.

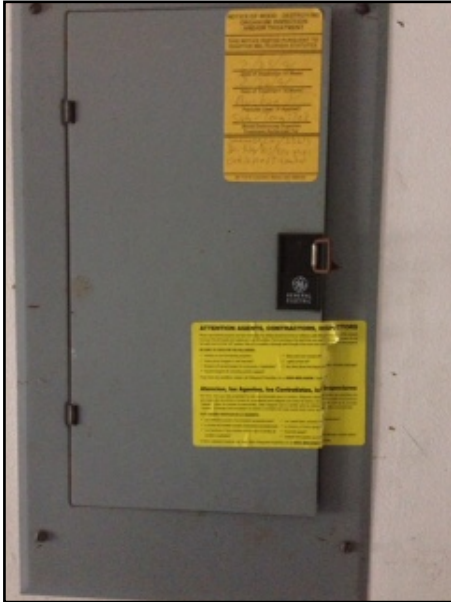
Figure 12-1

1. GE 125 amp sub panel.
2. GE breaker cover panel noted.
3. Inside GE breaker panel.

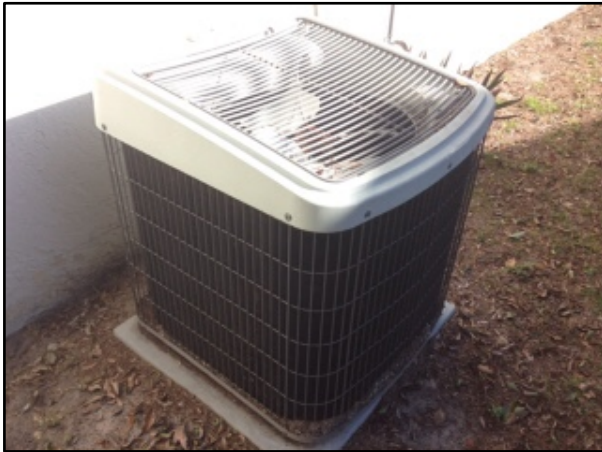
Figure 13-1

1. Tempstar condenser located outside.
2. Tempstar condenser installed in 2001.
3. Tempstar Air handler located in the attic.
4. Tempstar Air handler installed in 2001.

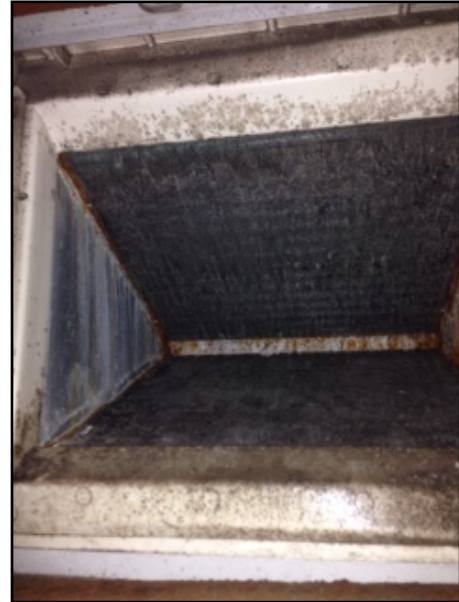
Figure 14-2

1. Insulation around suction line is starting to deteriorate recommend replacing insulation.
2. Coil is dirty and needs to be cleaned recommend having A/C system serviced.

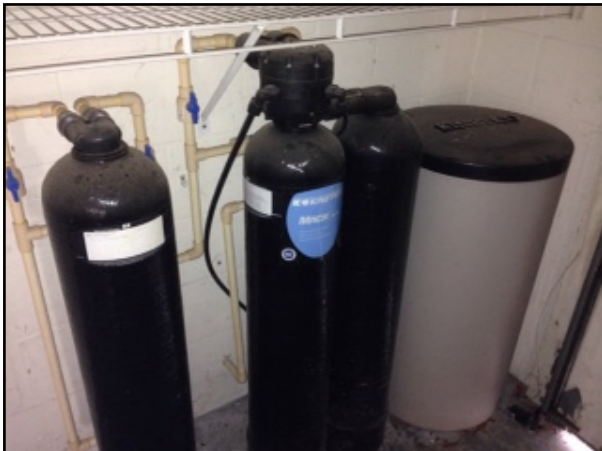
Figure 16-1

1. Kinetco water softener located in the garage.

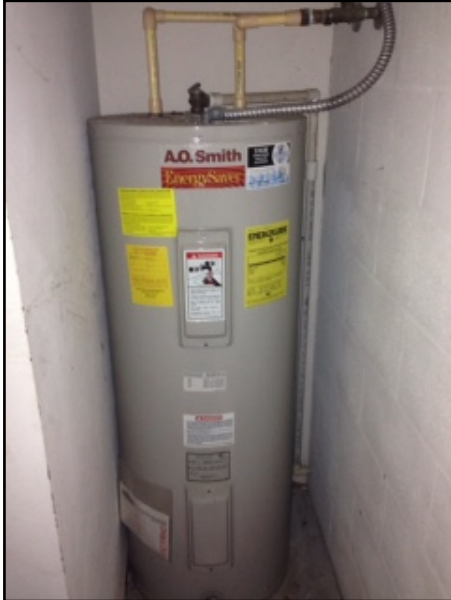
Figure 17-1

1. AO Smith hot water heater located in the garage.
2. AO Smith hot water heater installed in 2003.

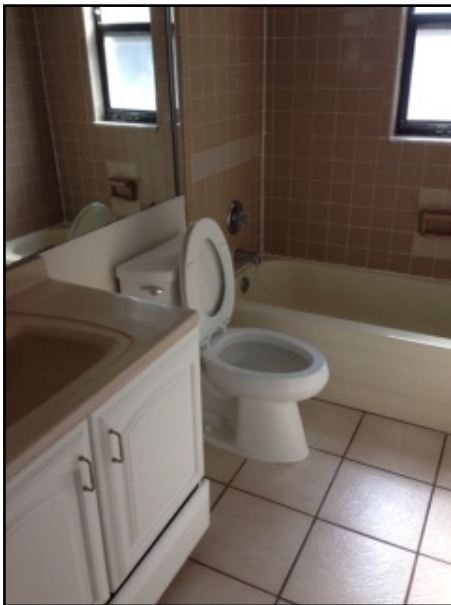
Figure 18-1

1. Photo of hallway bath.
2. Plumbing underneath bathroom vanity.

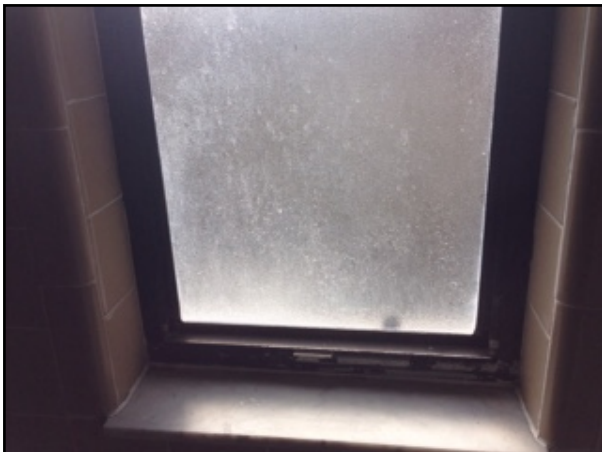
Figure 19-3

1. Water pressure was low recommend cleaning filter to see if the pressure is better.
2. Low water pressure on shower recommend cleaning or replacing shower head.
3. Window does not lock properly. Several windows are missing their locking mechanism and have small side locks.
4. Mirror is damaged at the bottom, cosmetic.

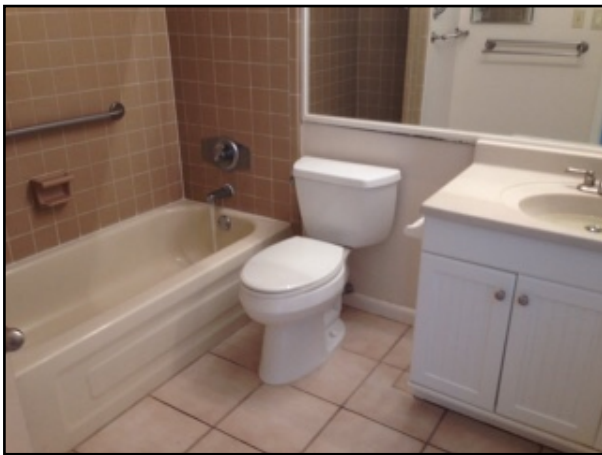
Figure 20-1

1. Master bath photo noted.
2. Master bath plumbing noted.

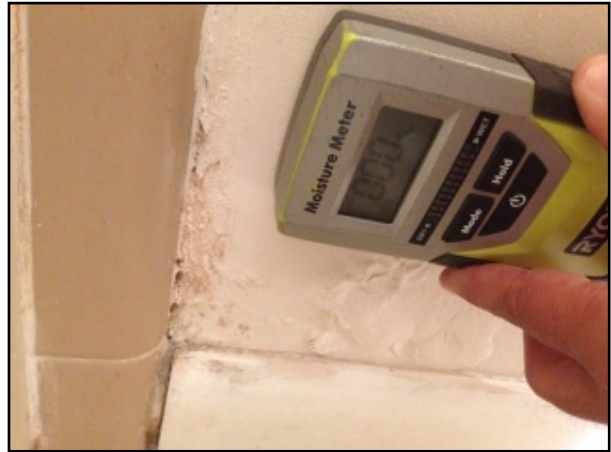
Figure 21-2

1. Sink was slow to drain recommend unclogging the drain.
2. Repair noted behind toilet checked with moisture meter no active moisture noted.
3. Recommend caulking around tiles to ensure a tight seal.
4. Tub has a small rust spot try to seal and continue monitoring.

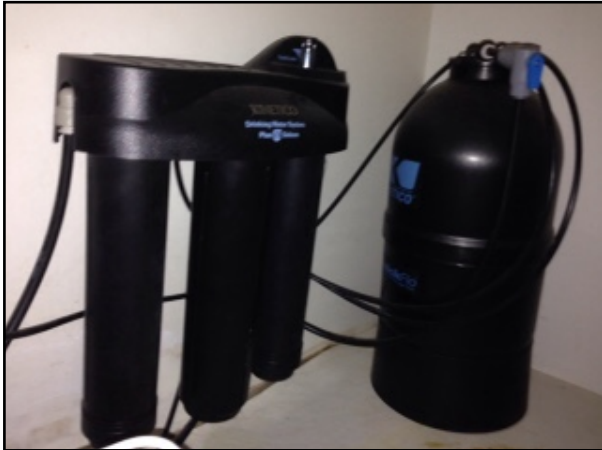
Figure 23-1

- i** Comment 23:
1. Kinetco water treatment system noted. Recommend calling company to service the equipment.
 2. Plumbing under kitchen sink noted.

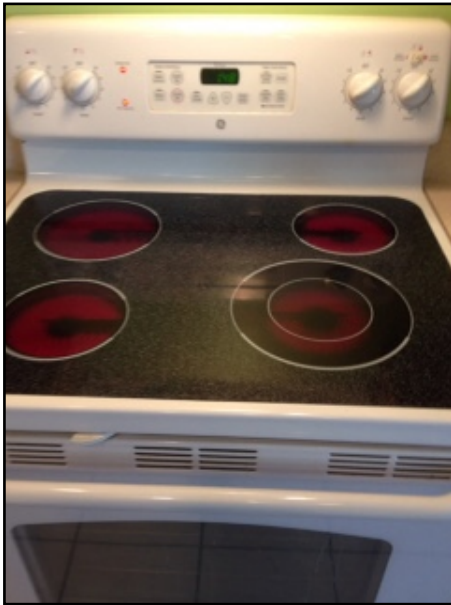
Figure 24-1

1. GE smoothtop range and oven noted.
2. Nu Tone range hood noted.
3. GE dishwasher noted. Dishwasher was noisy and dated.
4. Kenmore refrigerator noted.
5. Badger disposal noted under the sink.

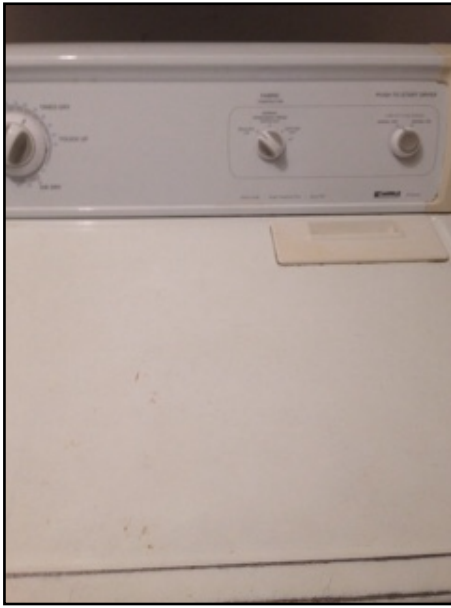
Figure 25-1

1. Kenmore dryer noted.
2. Kenmore washer noted. Washer lines where not connected. Washer was not tested.
3. Washer hook ups noted.

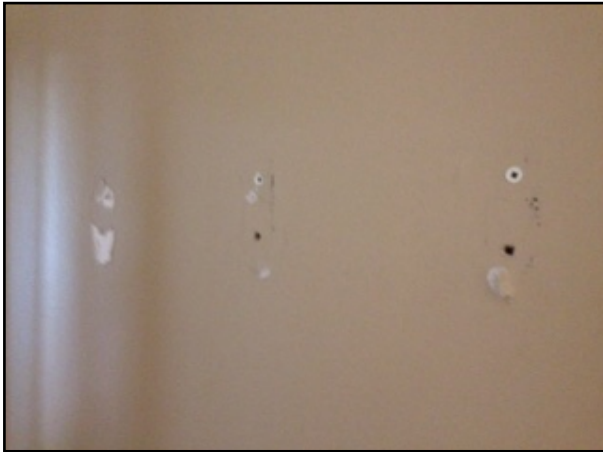
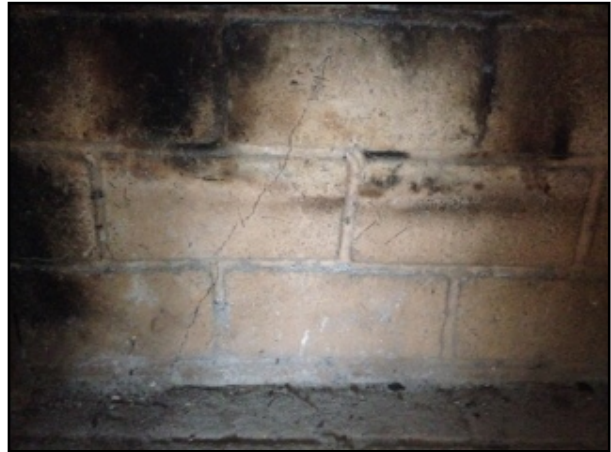
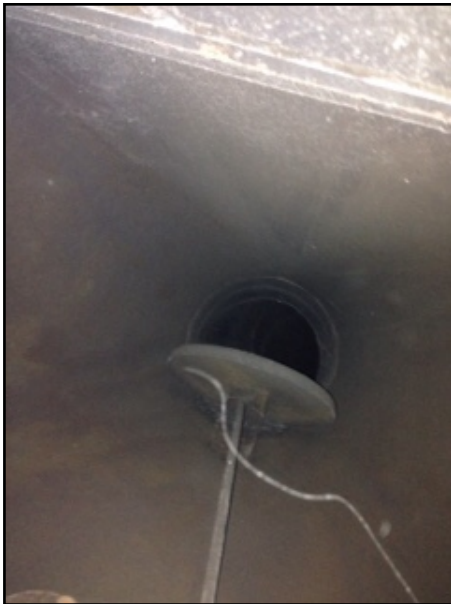
1. Several windows where difficult to operate recommend repair or replacement.
2. Ceiling fan is missing light fixture housing.
3. Several windows are missing screens and where difficult to operate.
4. Drywall repair needed at front window.
5. Door is missing at the front office.
6. French door latch is sticking recommend adjusting door.
7. Several holes noted on the walls recommend patching and painting.
8. Firebrick has a small crack continue to monitor and repair as needed.
9. Recommend having chimney cleaned and serviced on a yearly basis.

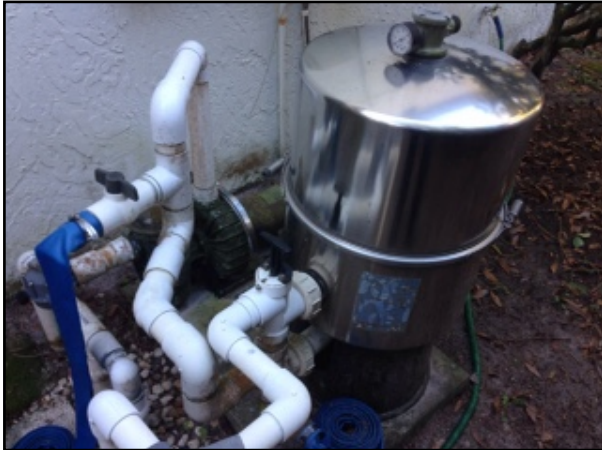
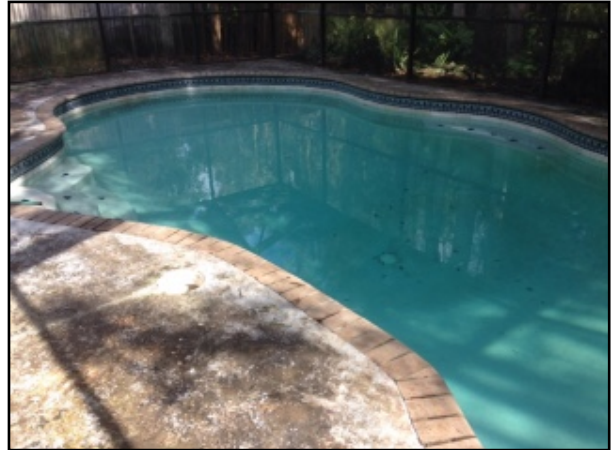
1. Pool equipment noted.
2. Inground pool noted.

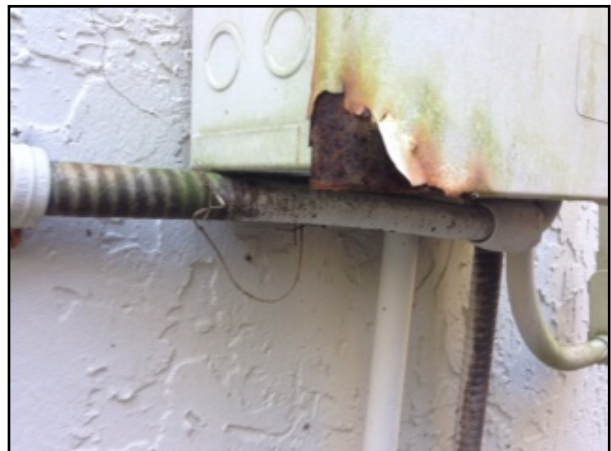
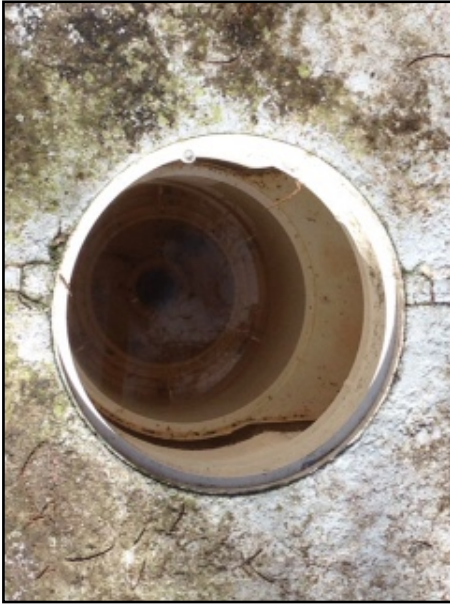
1. Pool motor needs to be replaced.
2. Rust noted at the bottom of the exterior shut off panel. Paint and continue to monitor.
3. Skimmer housing cover is missing.

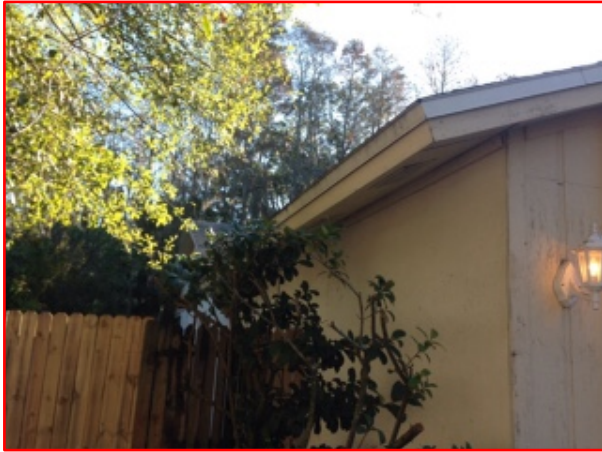
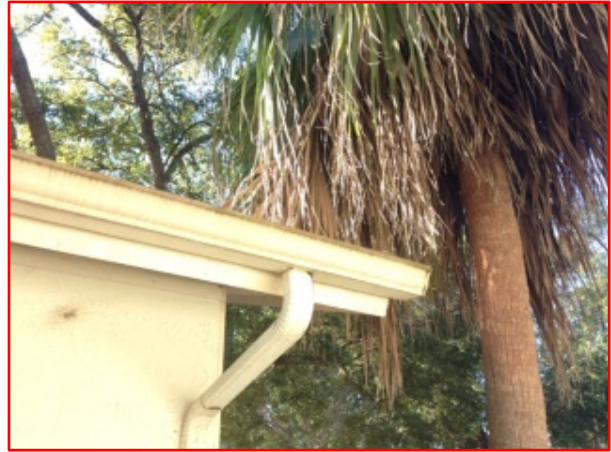
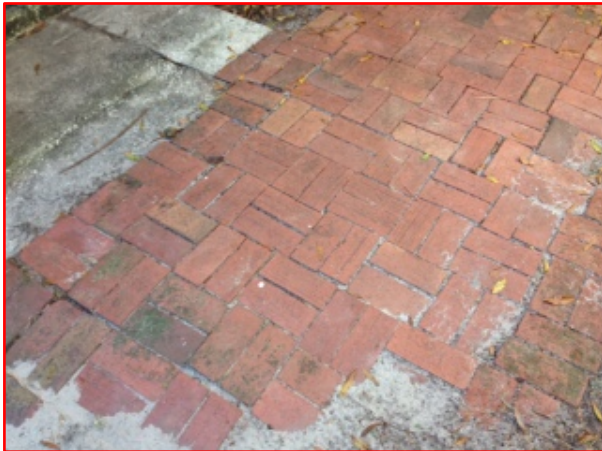
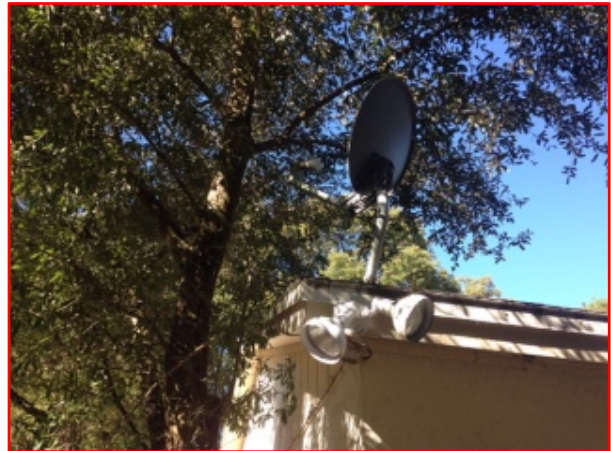
- 1) 1. Recommend trimming all vegetation away from the roof line.
2. Additional area where the vegetation needs to be maintained away from the roof structure.
3. Pavers on the side of the home are uneven and need to be re-leveled.
4. Additional vegetation which should be maintained away from the structure.

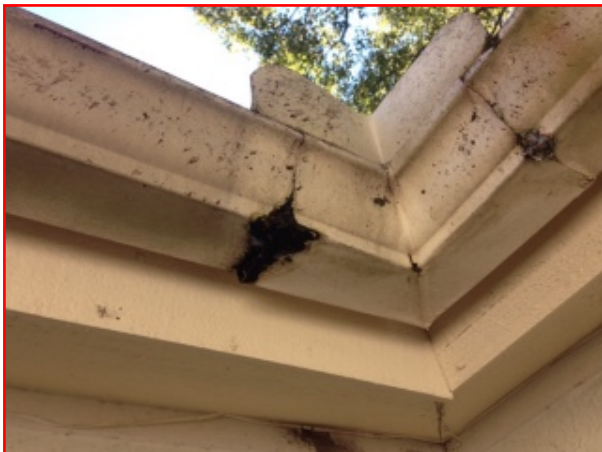
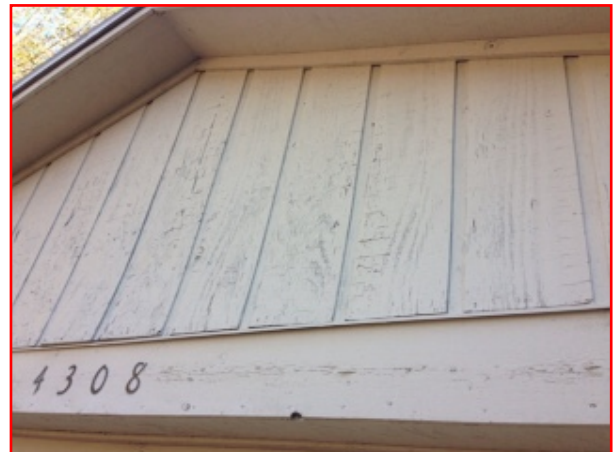
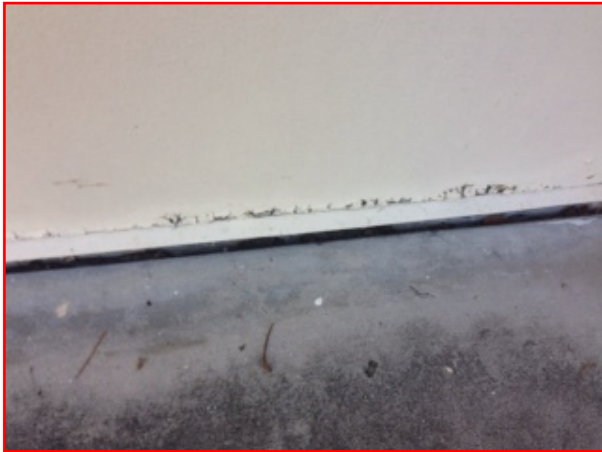
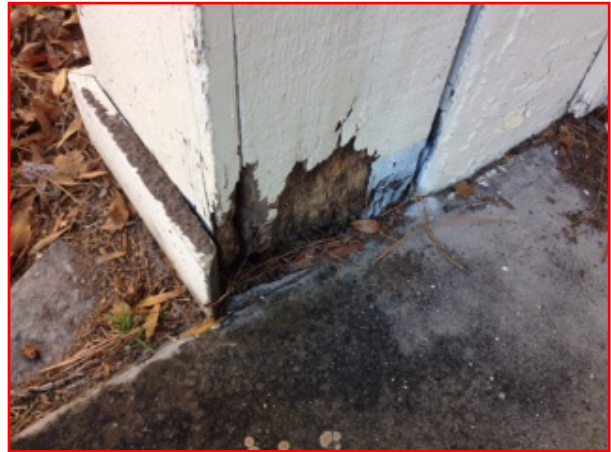
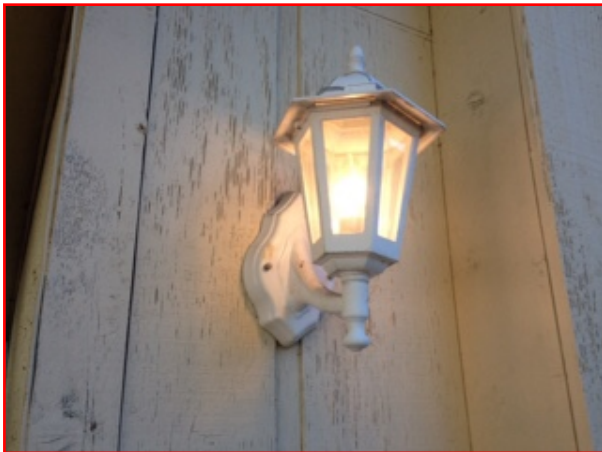
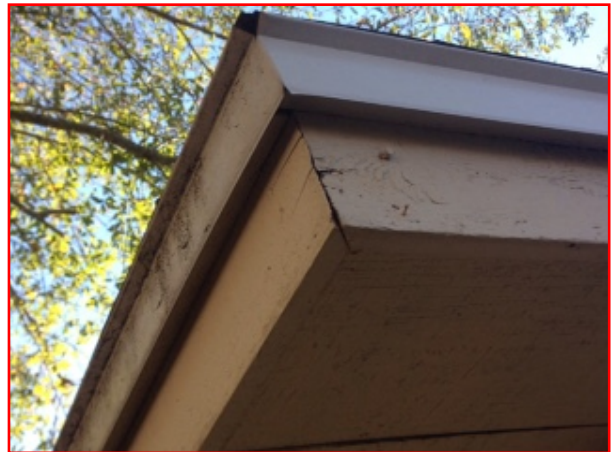
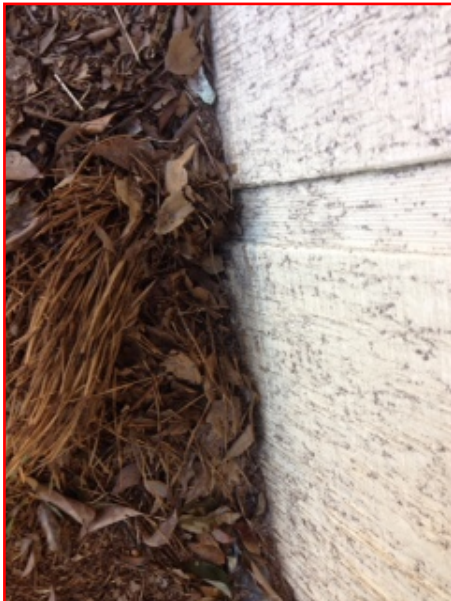
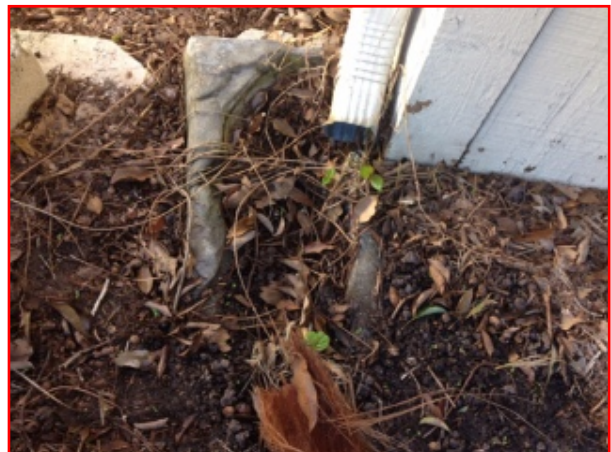
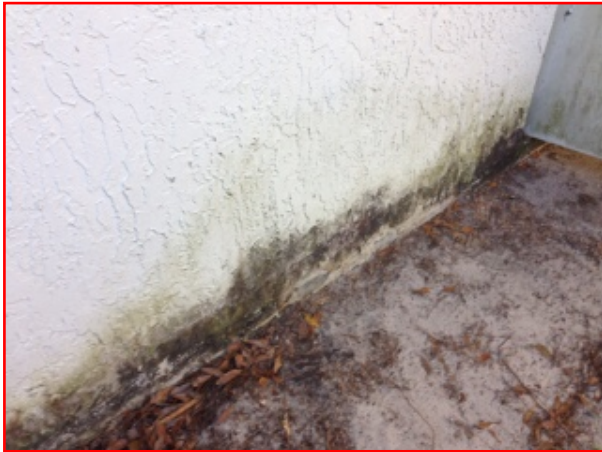
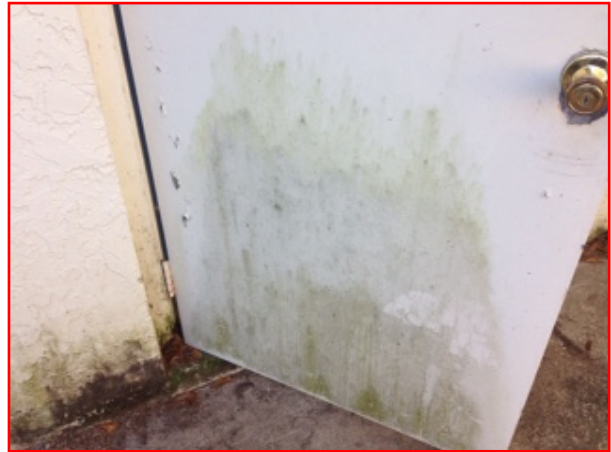
- 2) 1. Recommend sealing the seem at the gutter to ensure a tight seal.
2. Wood siding is warping and splitting recommend repair.
3. Bottom of garage door is peeling recommend repair and continued monitoring.
4. Wood trim has moisture damage and needs to be repaired.
5. Coachlight is loose and needs to be secured properly.
6. Recommend caulking all corners of fascia boards to ensure a tight seal.
7. Siding in front of the house is touching the soil recommend regrading to ensure that the soil is not touching the siding.
8. Recommend extending gutter downspout away from the structure.
9. Bottom portion of the home is stained and some of the paint is peeling recommend repair.
10. Side garage door paint is chipping and peeling recommend repair.

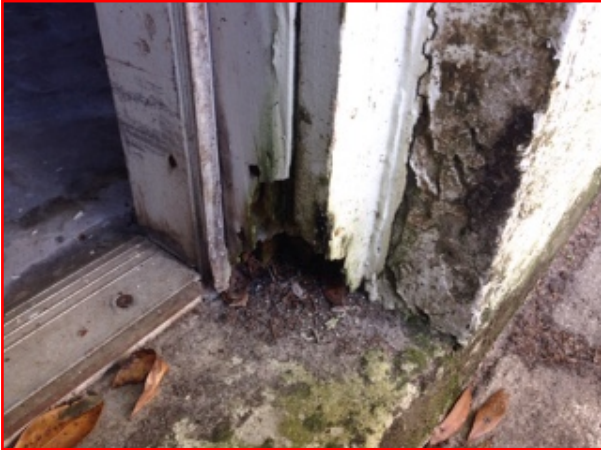
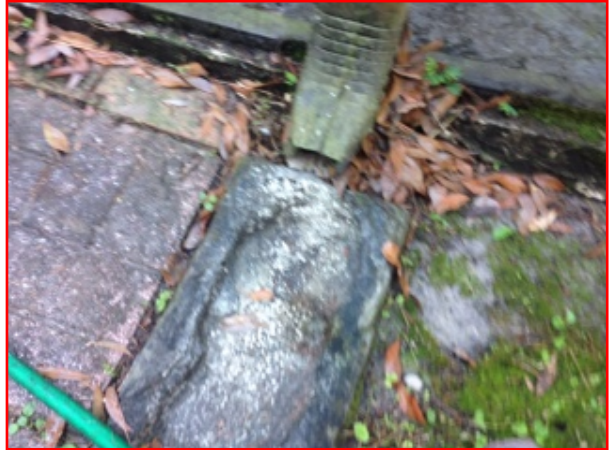
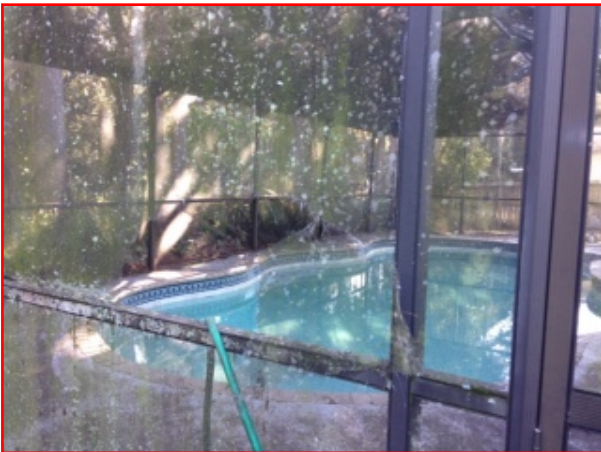
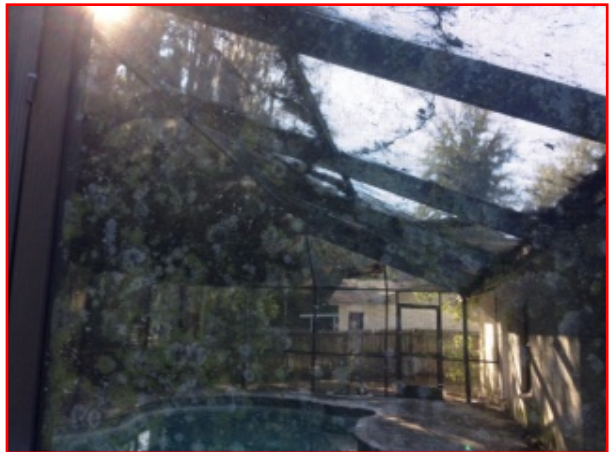
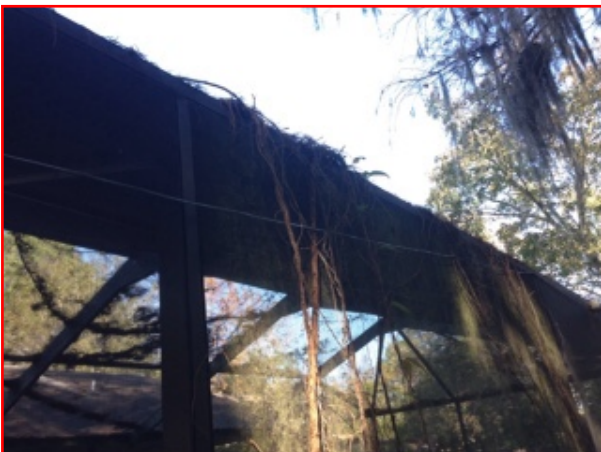
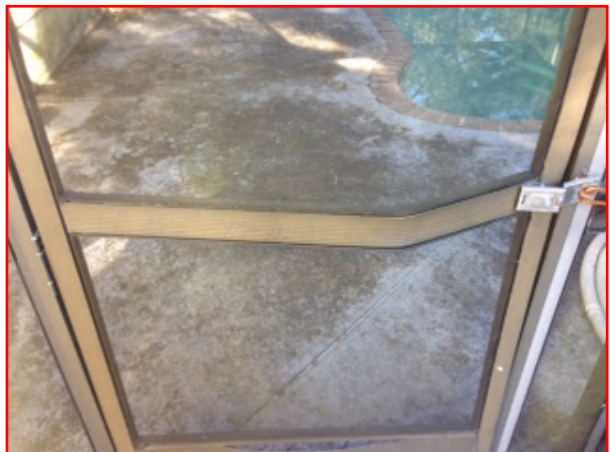
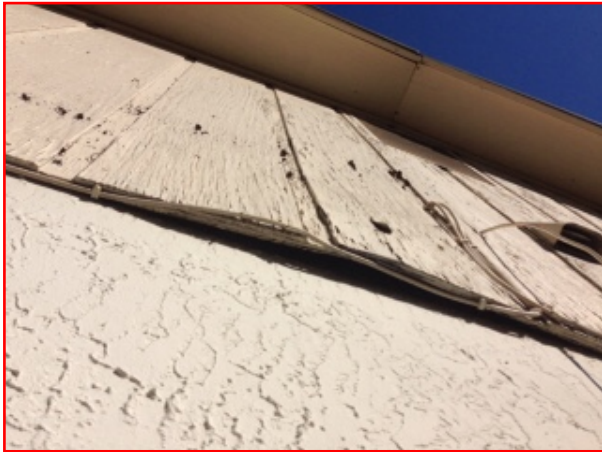
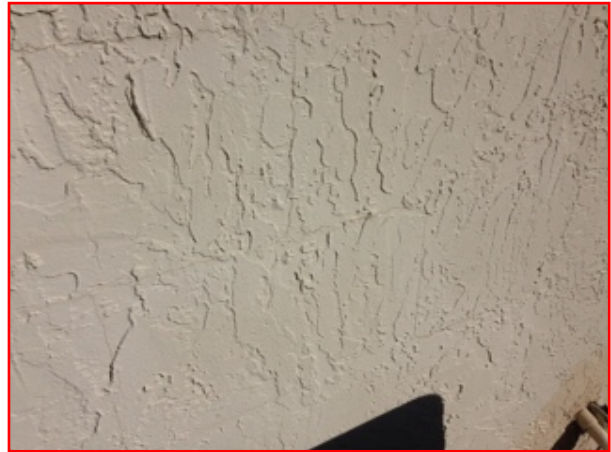
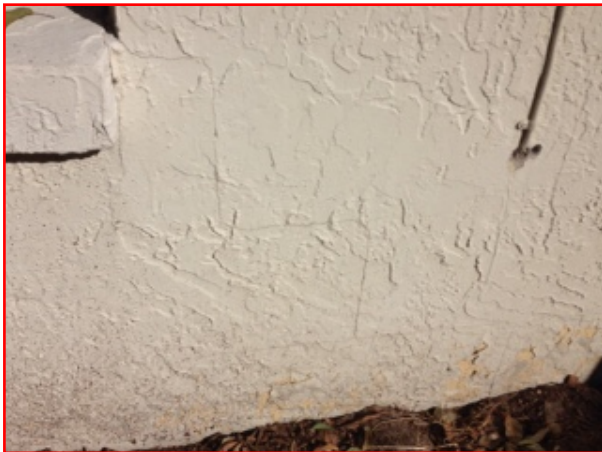
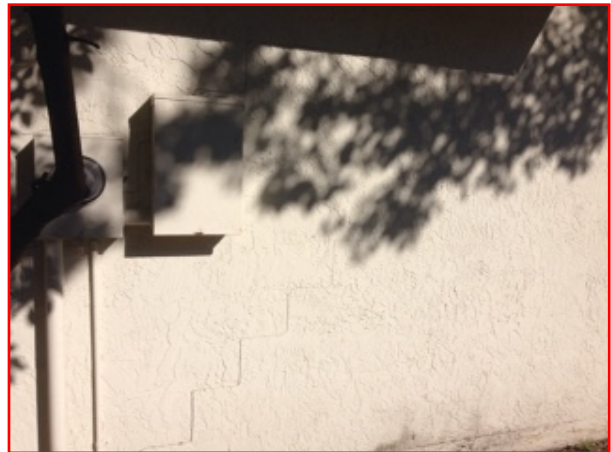
- 3) 1. Trim around side door garage has moisture damage and needs to be replaced.
2. Recommend extending gutter downspout away from the structure.
3. Screen is torn and has mildew and mold recommend replacing screen.
4. Additional photo showing mildew on the screen.
5. Recommend removing vine from back screen enclosure.
6. Screen door is damaged and needs to be repaired.
7. Siding has moisture damage and is warping recommend sealing properly and repairing as needed.
8. Step crack noted on the structure recommend caulking and continue to monitor.
9. Additional step crack noted caulk and continue to monitor.
10. Larger step crack noted recommend caulking and continue to monitor.

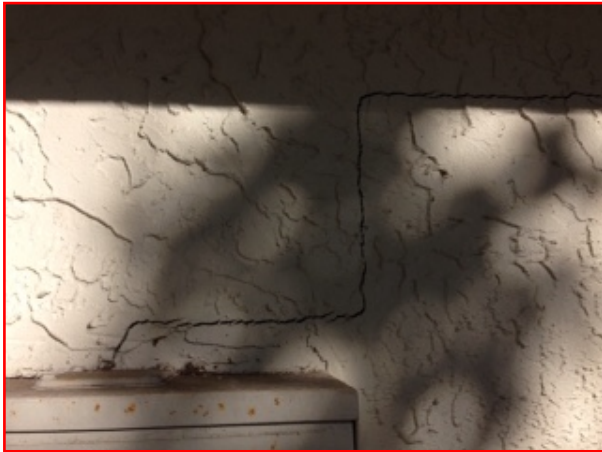
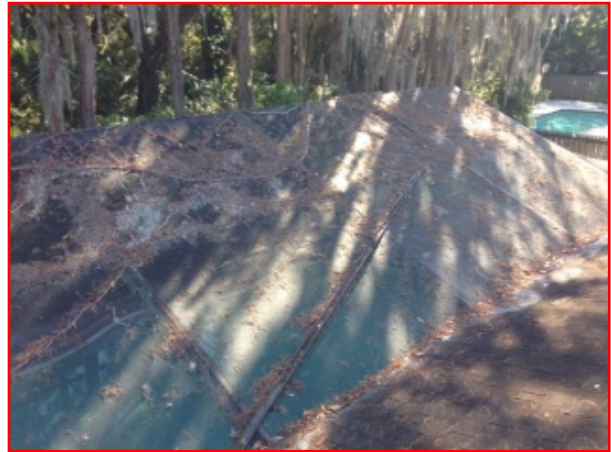
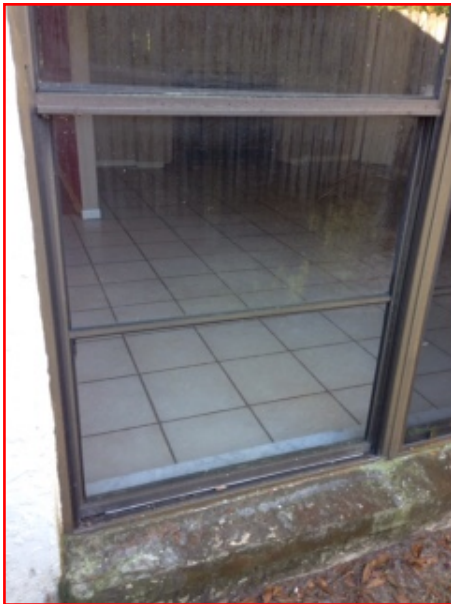
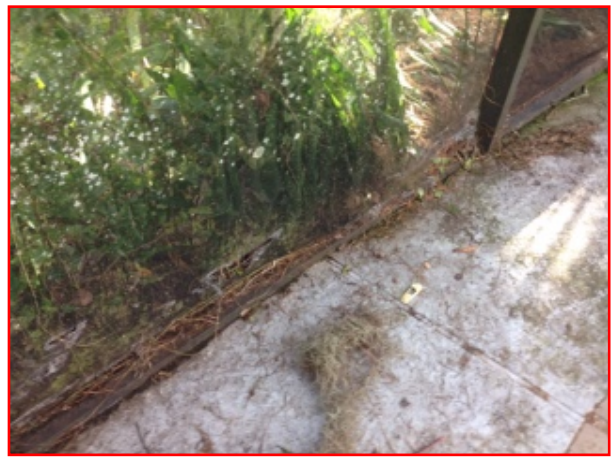
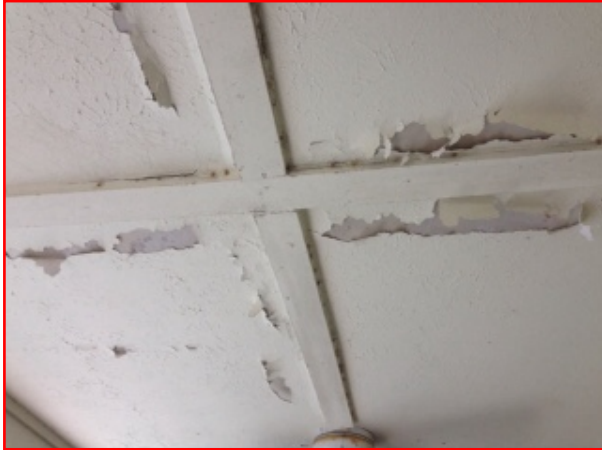
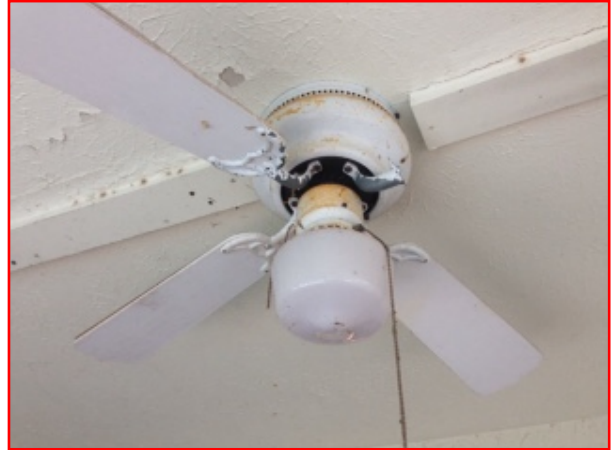
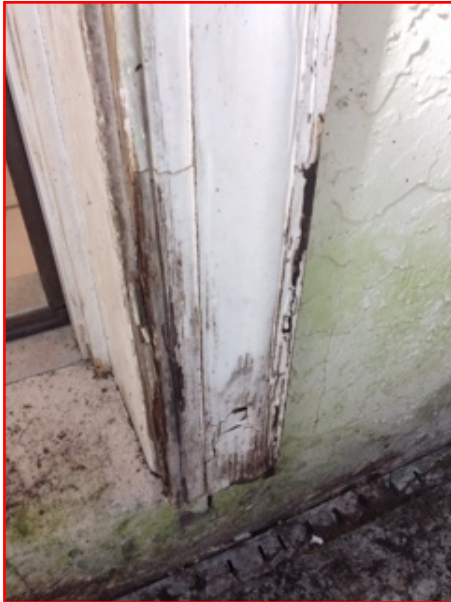
- 4) 1. Additional step crack noted caulk and continue to monitor.
2. Recommend removing all debris off of the screen enclosure.
3. Several windows are missing screens.
4. Additional screen which is damaged and needs to be repaired.
5. Ceiling under the covered patio is chipping and peeling recommend repainting.
6. Ceiling fans are damaged and need to be replaced with proper outdoor fans.
7. Exterior trim at patio door is damaged and should be replaced.

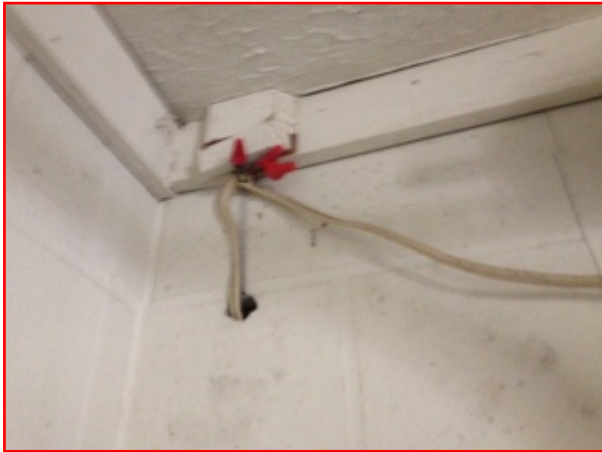
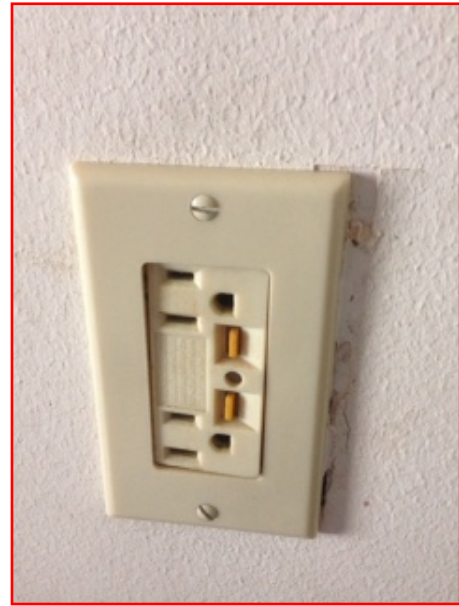
- 5) 1. Coachlight wiring junction is exposed, wire needs to be in a proper electrical box. Electrical wire needs to be in a conduit. Recommend further evaluation by a licensed electrician.
2. Recommend replacing older GFCI receptacle with a new GFCI receptacle.

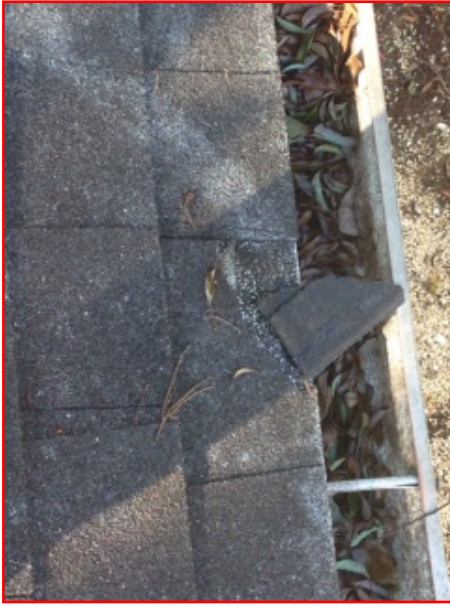
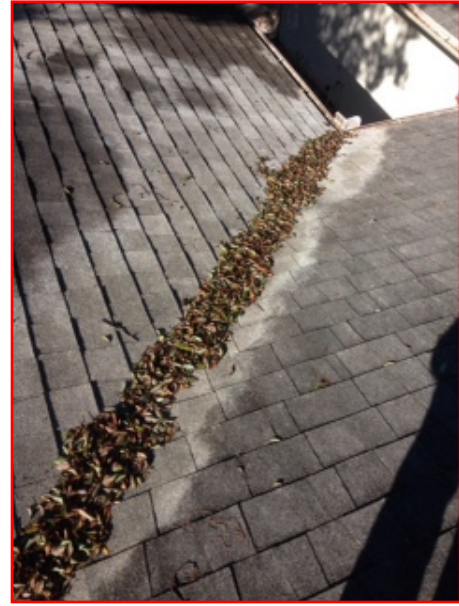
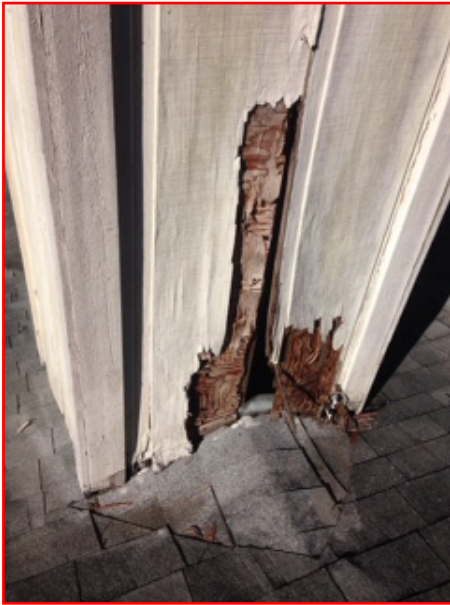
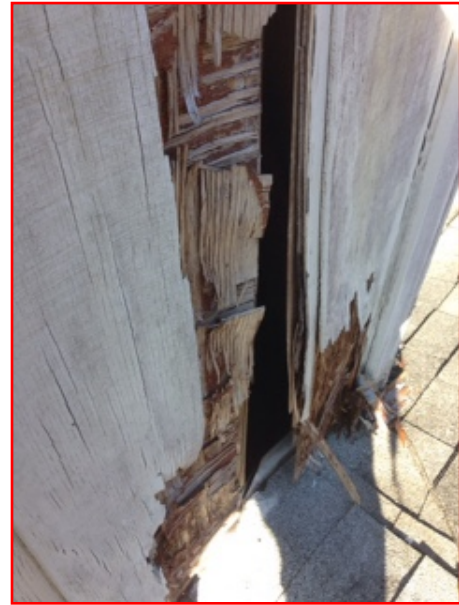
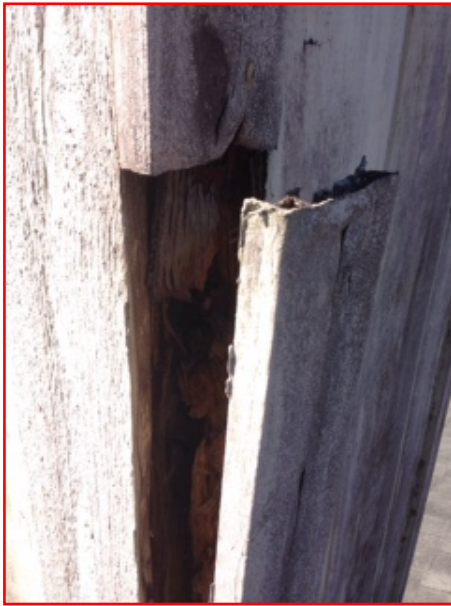
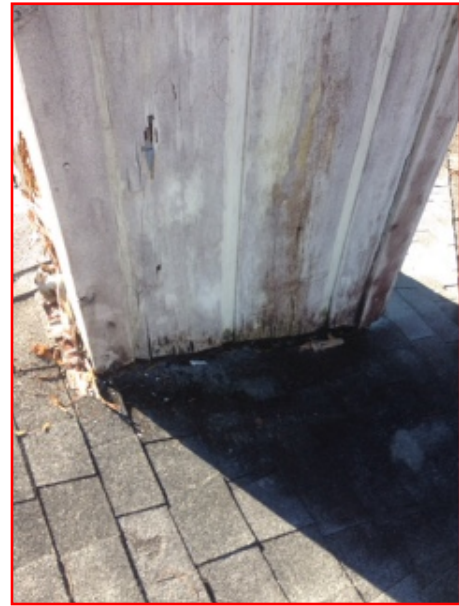
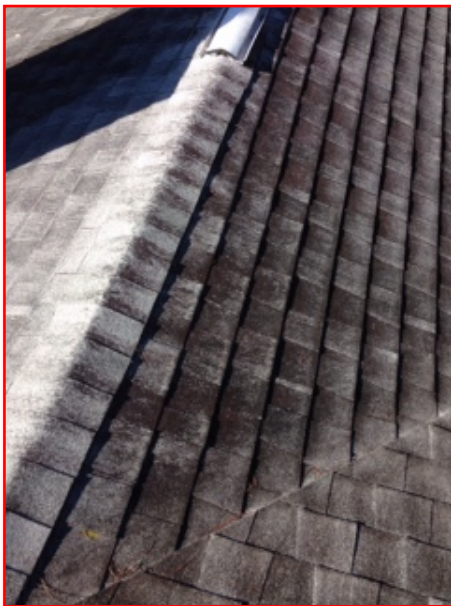
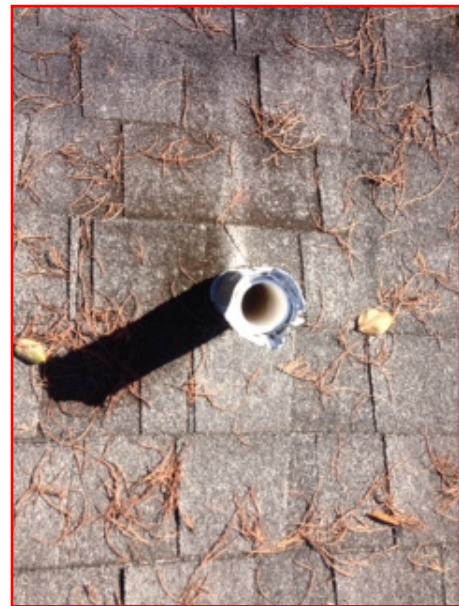
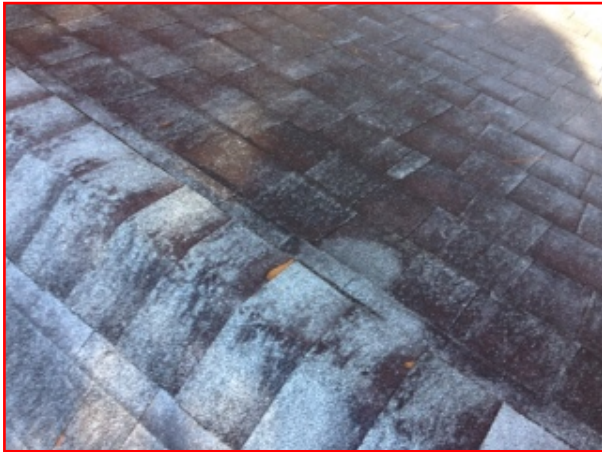
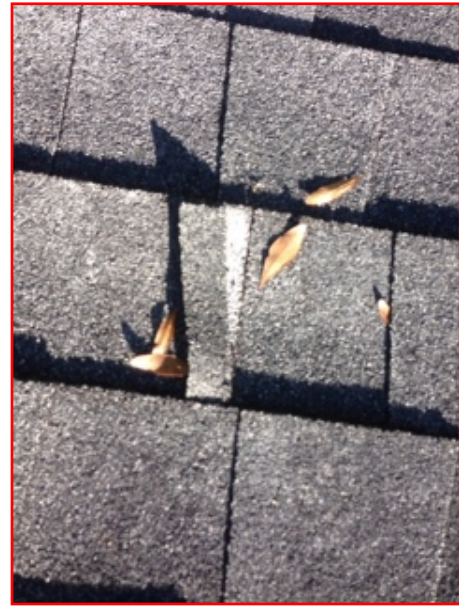
- 6) 1. Shingle is damaged and needs to be repaired.
2. Recommend cleaning all valleys of leaves and debris to allow for proper water discharge.
3. Back of the chimney has severe moisture damage recommend replacing all trim around the chimney.
4. Additional photo of damage around chimney.
5. Damage noted around trim at chimney recommend replacing.
6. Bottom of the chimney trim has a moisture damage recommend replacing all trim and adding additional flashing to deviate water away from the chimney.
7. Shingles in this area are slightly worn due to debris from tree branches and leaves. Continue to monitor.
8. Recommend adding screens to all roof vent stacks.
9. Additional area on the roof which is worn continue to monitor.
10. Small piece of shingle is loose and needs to be secured or repaired.

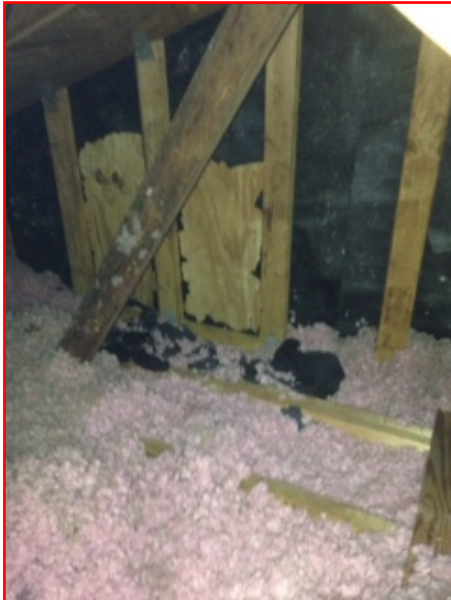
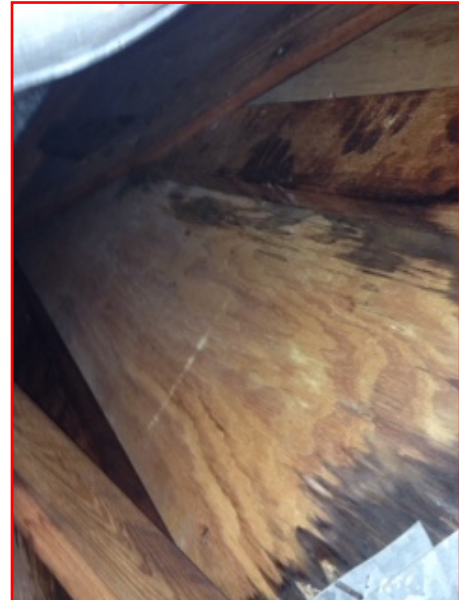
- 7) 1. Some of the vapor barrier has come loose recommend adding new barrier.
2. Moisture noted inside the chimney walls due to the exposed area on the roof. Recommend repairing as soon as possible to avoid further damage.
