Direct Inspect

Home Inspection Report

123

Inspected on Thu, Dec 11 2014 at 9:00 AM

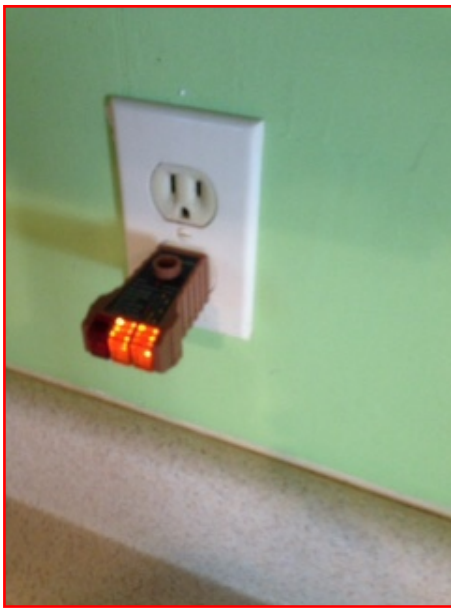
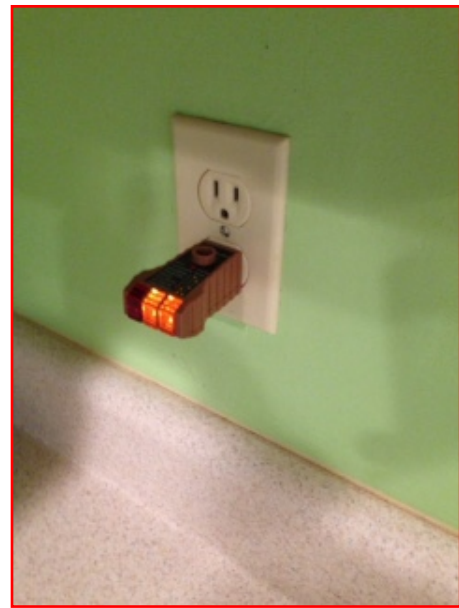
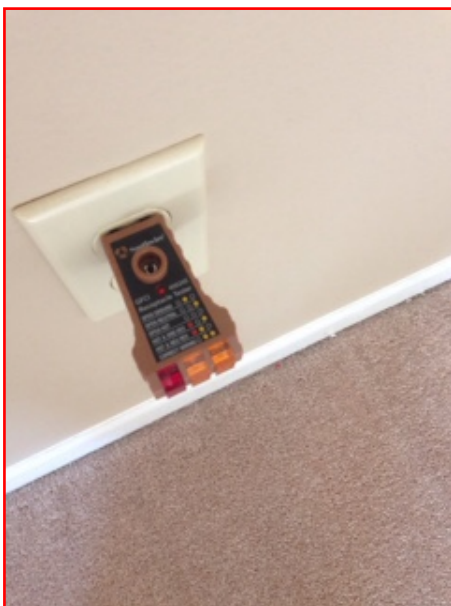
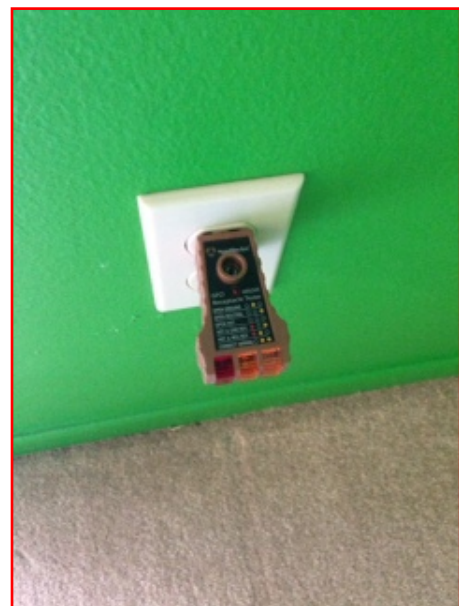
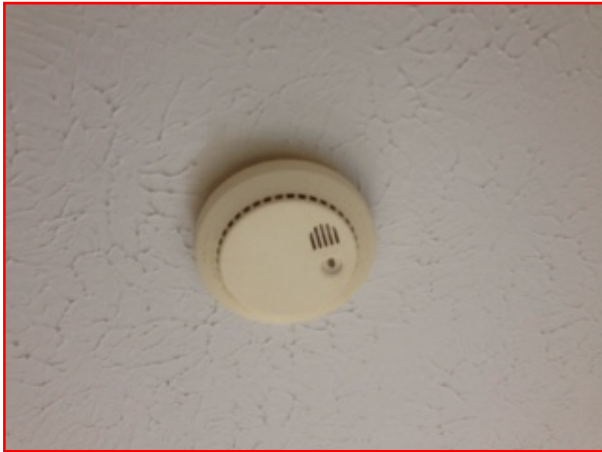
- 8) 1. Recommend replacing receptacle in kitchen with GFCI receptacle.
2. Additional receptacle in the kitchen which should be switched out to a GFCI receptacle.
3. Receptacle was loose and needs to be looked at by a licensed electrician. The power was intermittent.
4. Receptacle was inoperable recommend further evaluation.
5. Smoke detectors were both functional however when the smoke detectors turn yellow this is a sign that they should be replaced.

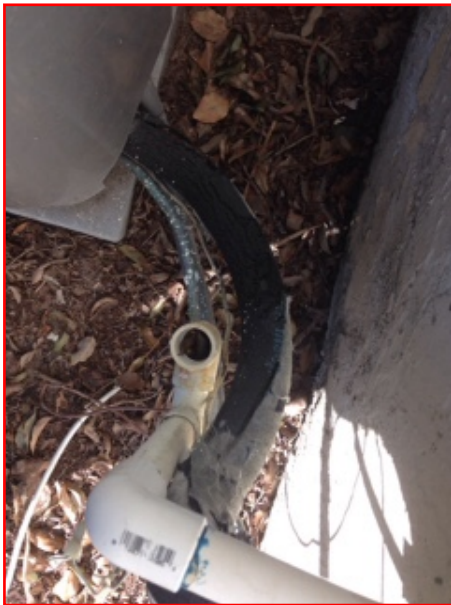
Figure 9-1

9) 1. Insulation around suction line is starting to deteriorate recommend replacing insulation.

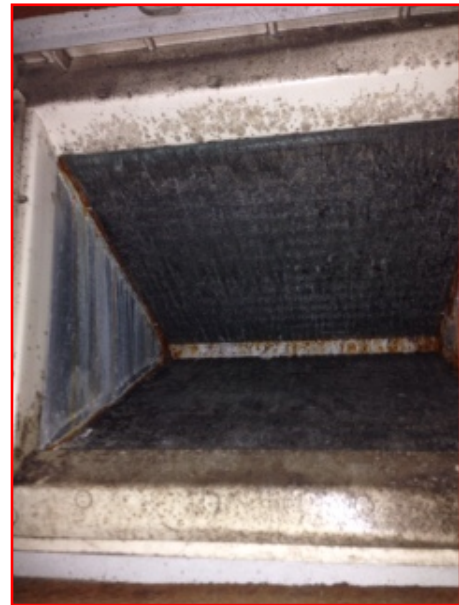
Figure 9-2

2. Coil is dirty and needs to be cleaned recommend having A/C system serviced.

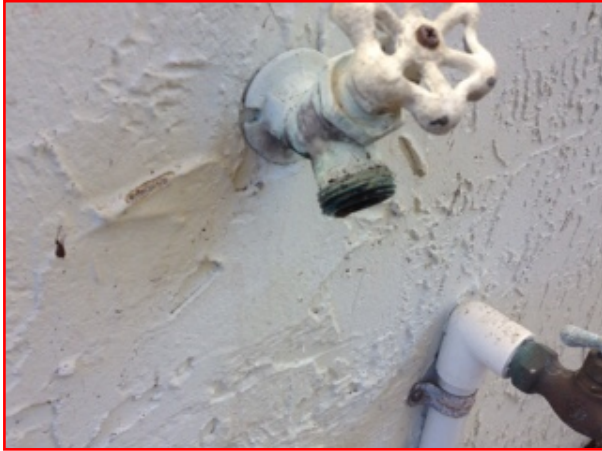
Figure 10-1

10) 1. Exterior hose bib is leaking recommend repair.

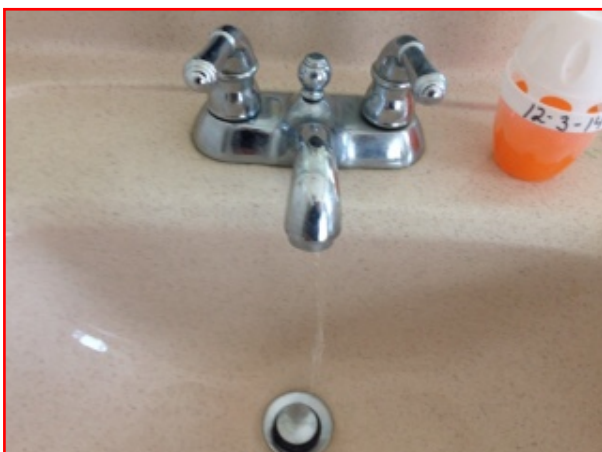
Figure 11-1

11) 1. Water pressure was low recommend cleaning filter to see if the pressure is better.

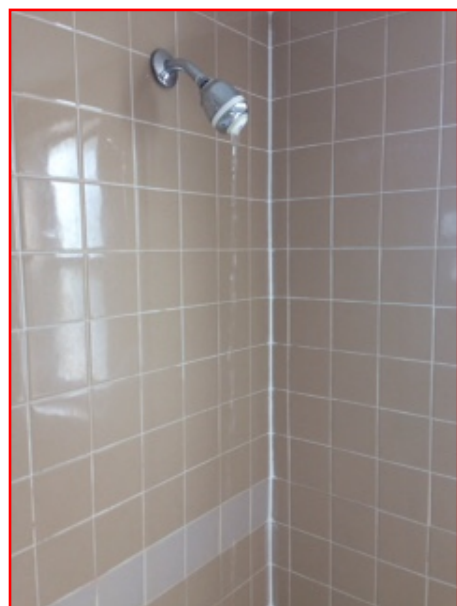
Figure 11-2

2. Low water pressure on shower recommend cleaning or replacing shower head.

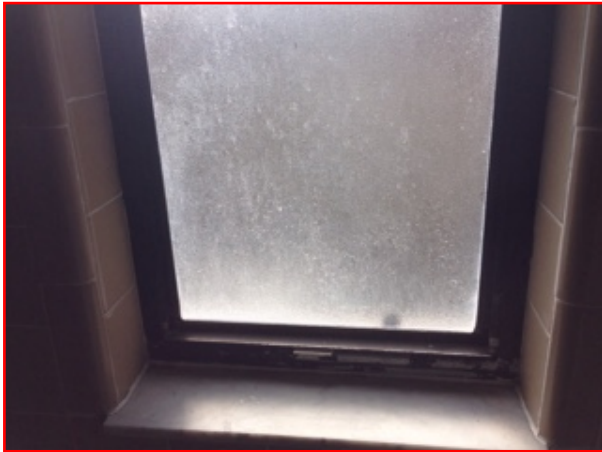
Figure 11-3

3. Window does not lock properly. Several windows are missing their locking mechanism and have small side locks.

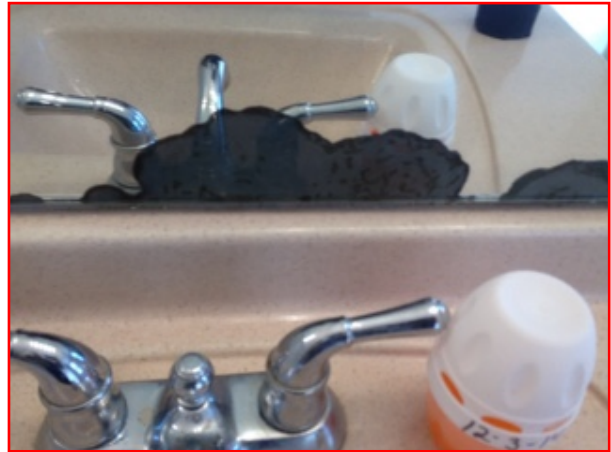
Figure 11-4

4. Mirror is damaged at the bottom, cosmetic.

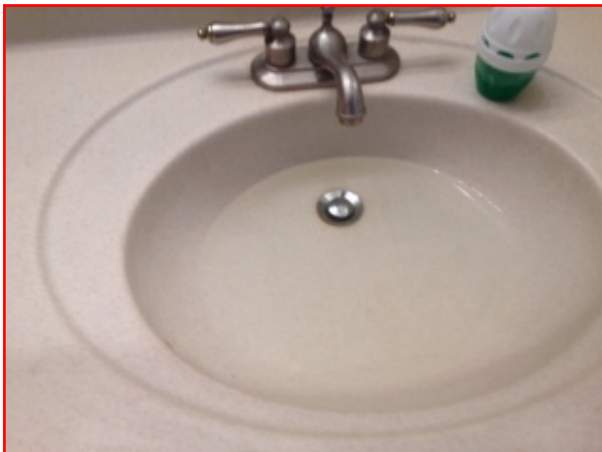
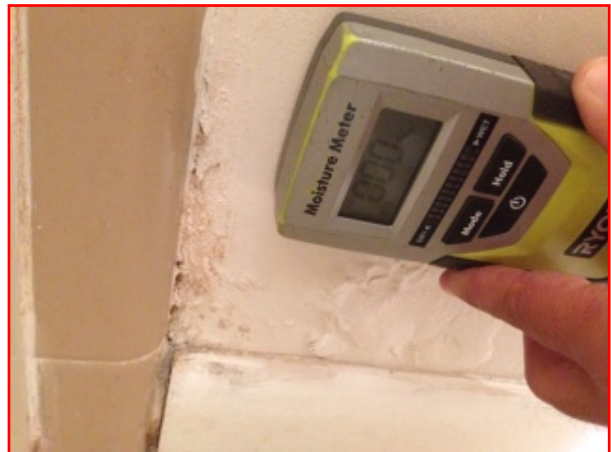
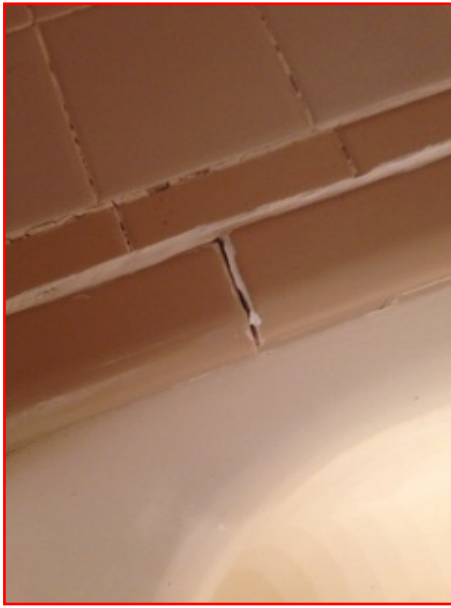
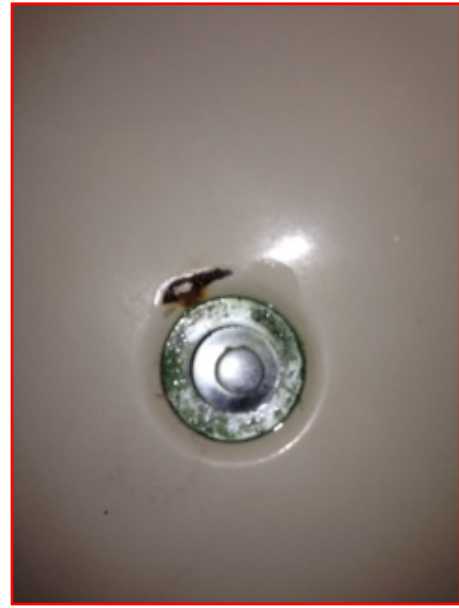
- 12) 1. Sink was slow to drain recommend unclogging the drain.
2. Repair noted behind toilet checked with moisture meter no active moisture noted.
3. Recommend caulking around tiles to ensure a tight seal.
4. Tub has a small rust spot try to seal and continue monitoring.

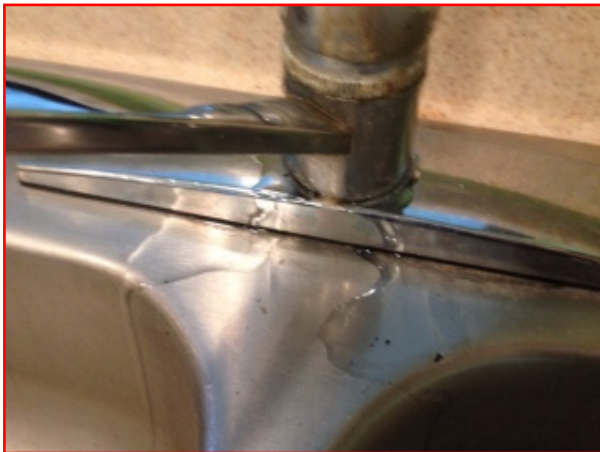
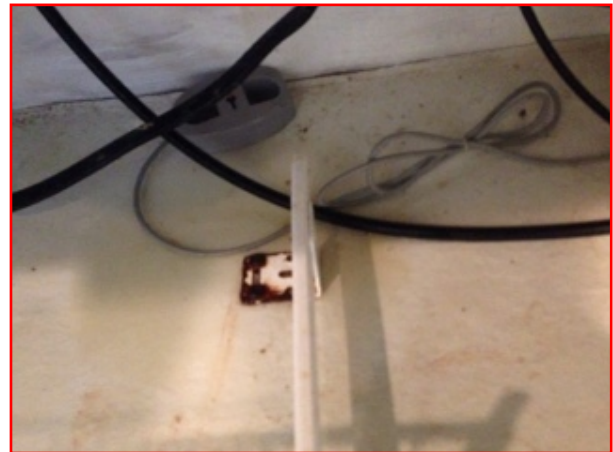
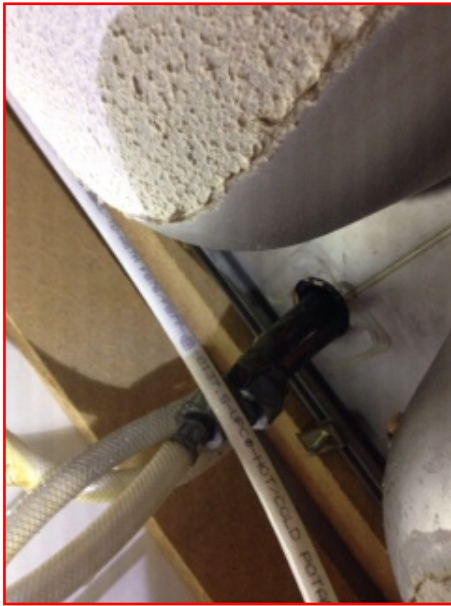
- 13) 1. Leak noted at faucet fixture when turned on replace fixture.
2. Water noted at base cabinet from leak.
3. Leak appears to be coming from the faucet fixture repair or replace as needed.

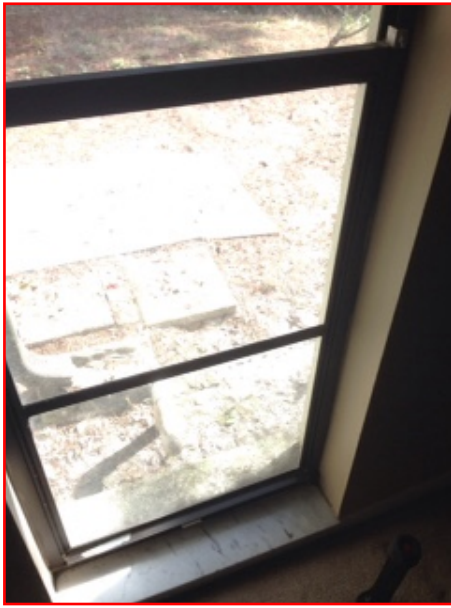
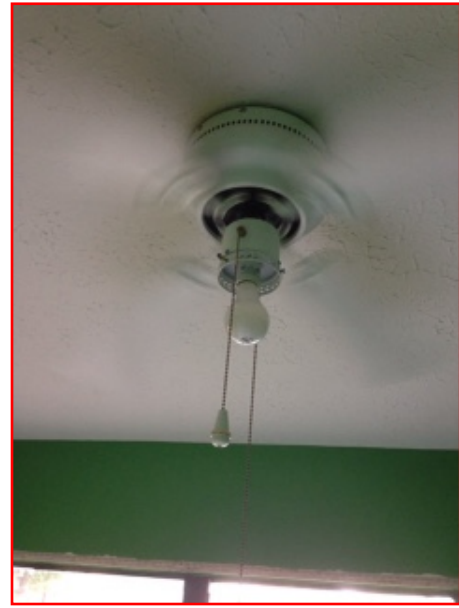
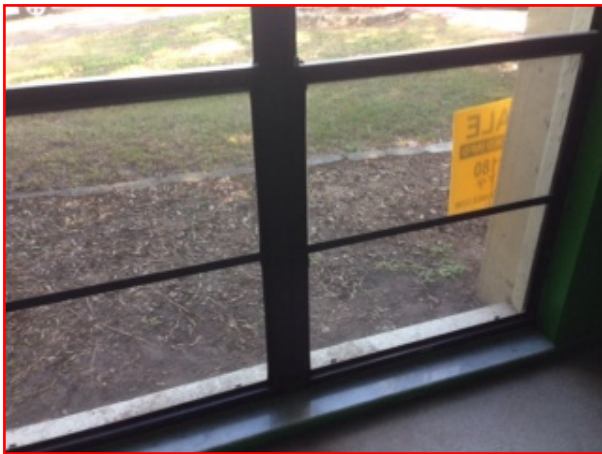
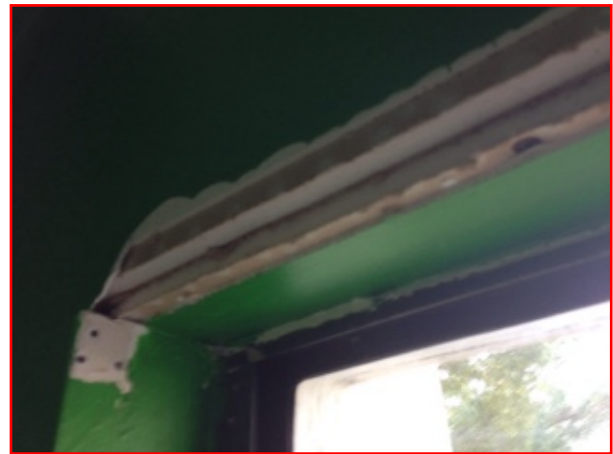
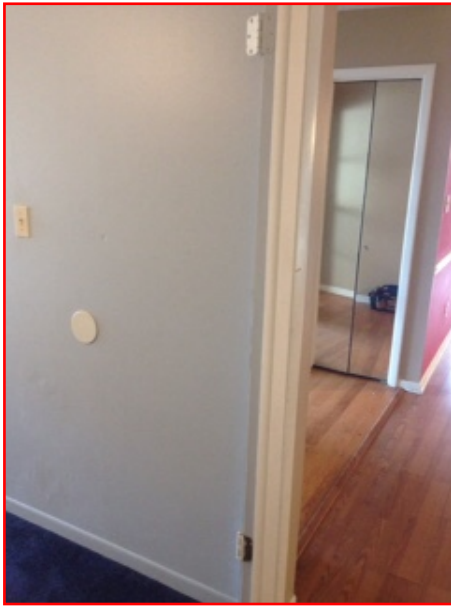
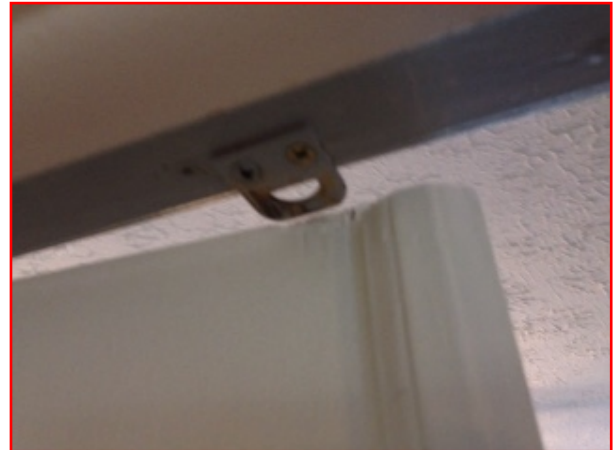
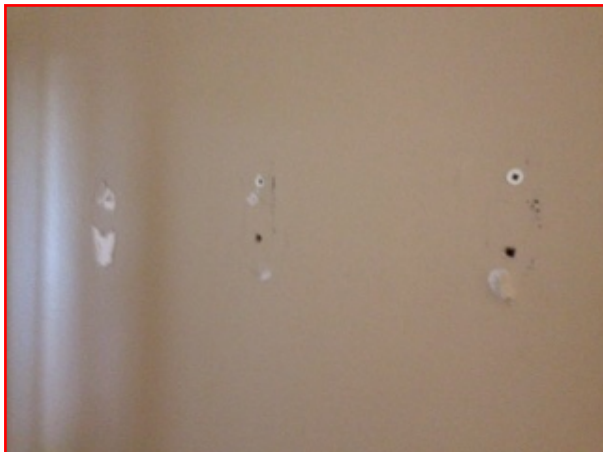
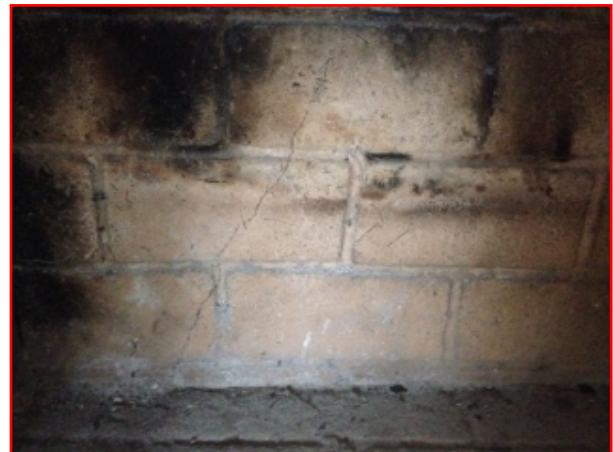
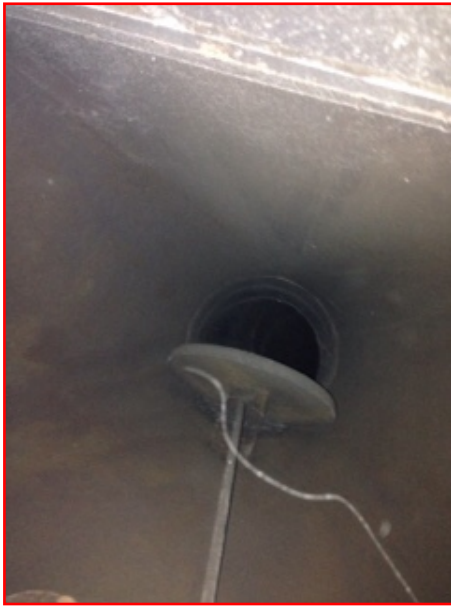
- 14) 1. Several windows where difficult to operate recommend repair or replacement.
2. Ceiling fan is missing light fixture housing.
3. Several windows are missing screens and where difficult to operate.
4. Drywall repair needed at front window.
5. Door is missing at the front office.
6. French door latch is sticking recommend adjusting door.
7. Several holes noted on the walls recommend patching and painting.
8. Firebrick has a small crack continue to monitor and repair as needed.
9. Recommend having chimney cleaned and serviced on a yearly basis.

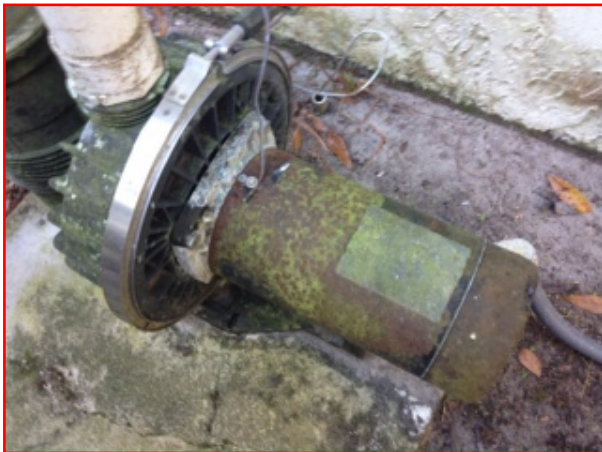
Figure 15-1

- 15) 1. Pool motor needs to be replaced.
2. Rust noted at the bottom of the exterior shut off panel. Paint and continue to monitor.
3. Skimmer housing cover is missing.
